PFR SPTS No. 25684

## **Poplars and willows as bioengineering solutions for riverbank flood protection – learnings from Cyclone Gabrielle**

Mclvor I, Heslop I, Brooks F

June 2024

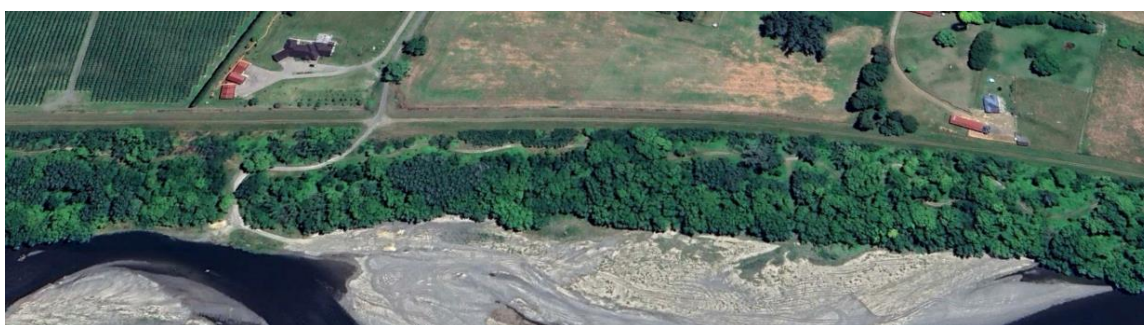
**Figure 8.** Pre-Gabrielle; Dec 2021.

The stopbank was set back 70 m from the riverbank, and most of the berm width was planted, which in normal floods would offer erosion protection to the stopbank. However, the cyclone flows significantly exceeded the floodway capacity, and the adjacent stopbank overflowed and breached. The siphoning-off of large breach flows from the main channel, combined with the directional effects of Ebbetts floodplain return flows, combined to wash out or flatten the berm planting. Fortunately, the river channel alignment held due to the combination of bank and berm erosion protection measures in place. The post-cyclone aerials showed partial regrowth of the poplars and willows flattened by floodwaters, which demonstrates the durability of the remnant erosion protection planting. The aerial photos below (Figures 8 & 9) show the pre- and post-cyclone riverbank and berm protection planting.

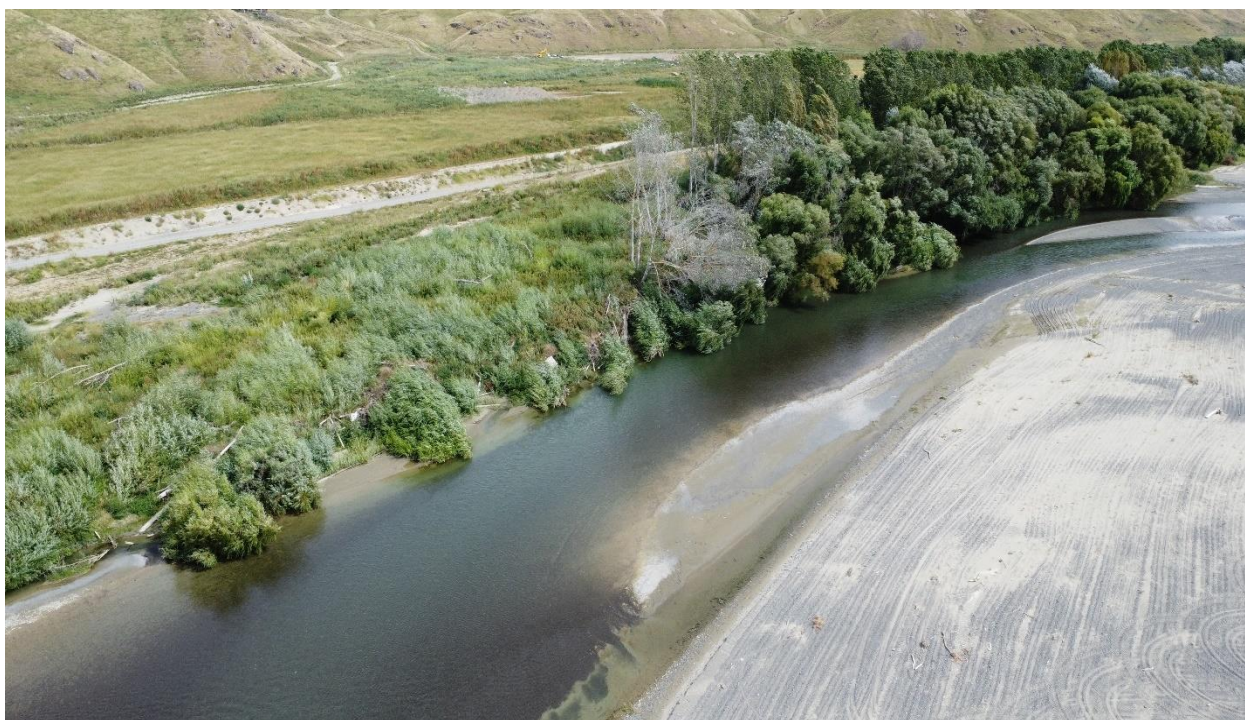
**Figure 11.** Regrowth of mature willows and poplars, flattened by overland flood flow return, contrasted with unaffected standing trees upstream.

**Recommendation – cut through the fallen trunk somewhere above the stump to create two trees from one. Realign or relocate the cut off trunk as anchored or layered tree protection. This is suggested as a sensible approach to dealing with trees that have fallen on a poor alignment, either on the berm or into the channel. If left they could create a weakness in bank or berm protection.**

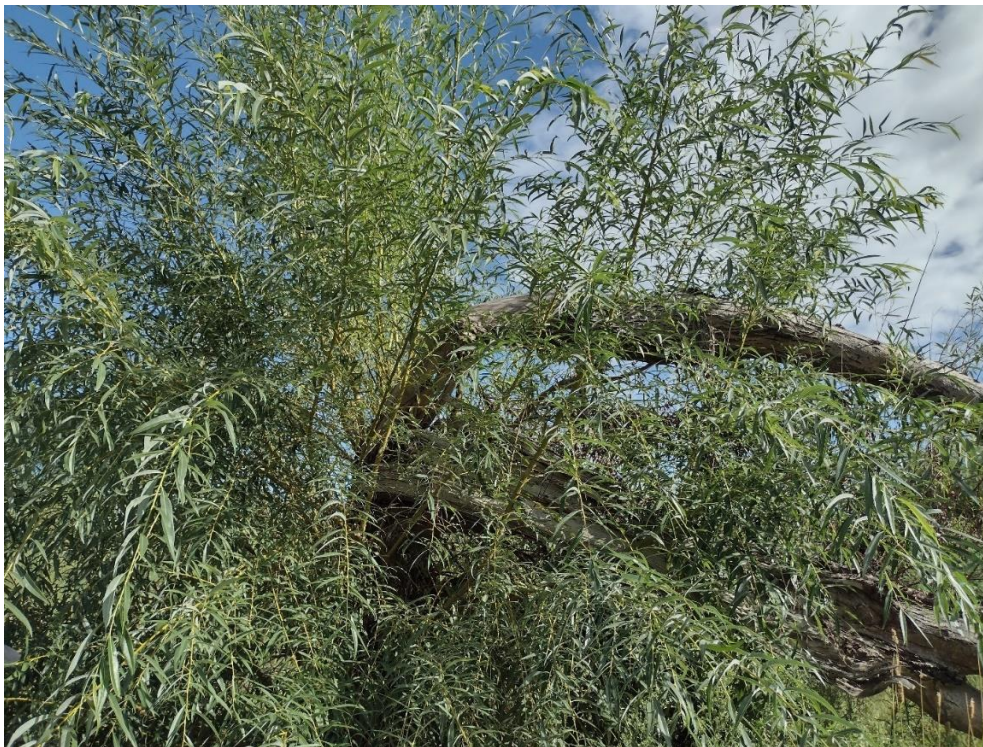
Flattened willows were not uprooted, they were still anchored in the soil/sediment by live roots (Figures 12 & 13). Any reorientation should consider whether the live roots may be broken off, with resulting slowing of regrowth of shoots, particularly from the stump area.

**Figure 12.** Shoot regrowth, after one year, from a tree willow flattened from behind by floodwaters. The trunk-soil connection remained intact.

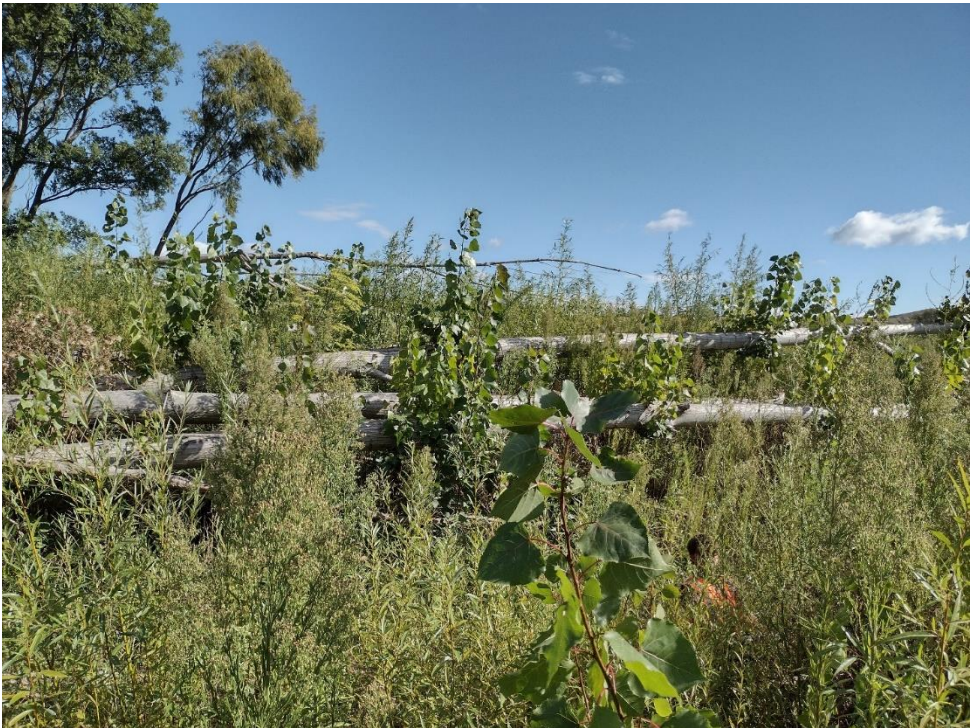
Flattened poplars (Figure 13) were more damaged. The trunk-soil connection was largely intact, but the prostrate trees will create management problems. Our recommendation is to remove them and replant replacement poles.

**Figure 13.** Shoots resprouting from flattened poplars. Almost all the bark was stripped by the abrasive floodwaters, leaving little opportunity for recovery from the trunk.

**Recommendation – that any debarked trunk be cut off and removed. They will always be a weak protection asset.**

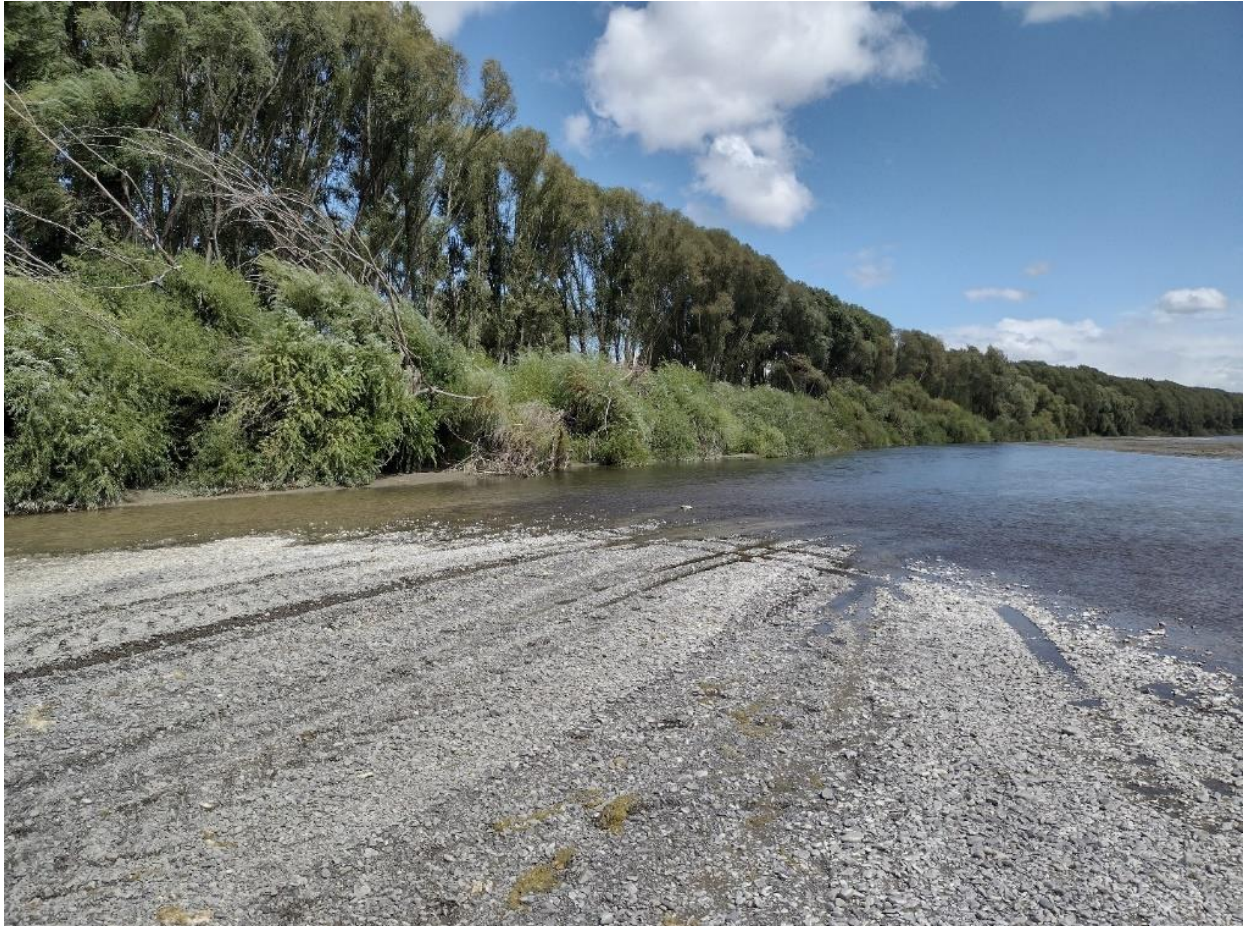
**Figure 14.** Recovery of front row of tree willows layered by floodwaters in the main channel, one year on from Cyclone Gabrielle.

**Recommendation – that bank and berm protection plantings are maintained by appropriate planting, layering, and mulching as required.**

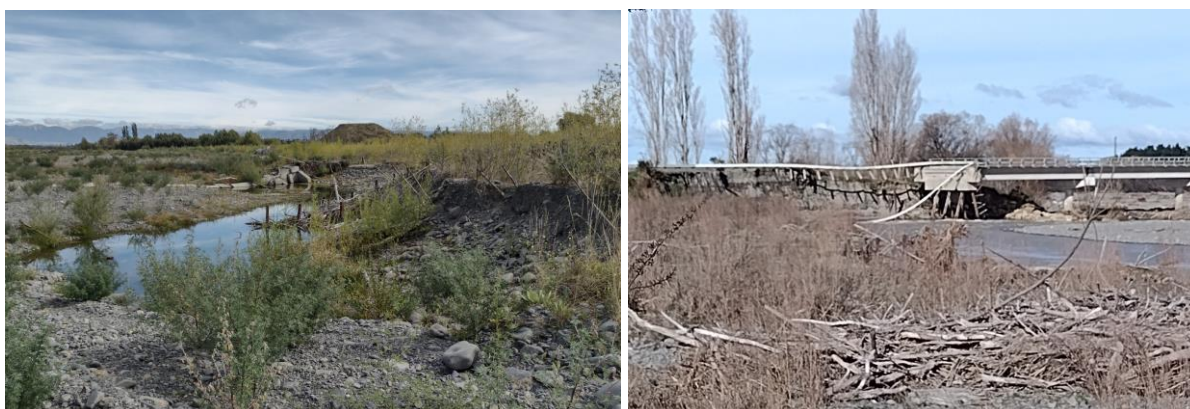
A comprehensive project was undertaken upstream of SH50, and just prior to Cyclone Gabrielle, to secure the channel alignment and prevent damage to the SH50 Bridge. Works consisted of channel realignment, erosion bay infill, Akmon groynes, rope/rail groynes & training lines, and extensive tree planting (Figure 15). Infilled gravel areas closer to the river were planted with willow poles (*Salix matsudana x alba* hybrids), and poplar poles (*Populus x euramericana* 'Veronese') were planted higher up on the banks. Cyclone Gabrielle partially undermined the Akmon and rope/rail groynes causing bank erosion and channel realignment (Figure 16). A further flood in June 2023 further damaged these works upstream of SH50, resulting in bridge abutment wash-out and road closure.

**Figure 16.** Bank erosion with damaged Akmon & rope/rail groynes (left). SH50 Bridge wash out (right).

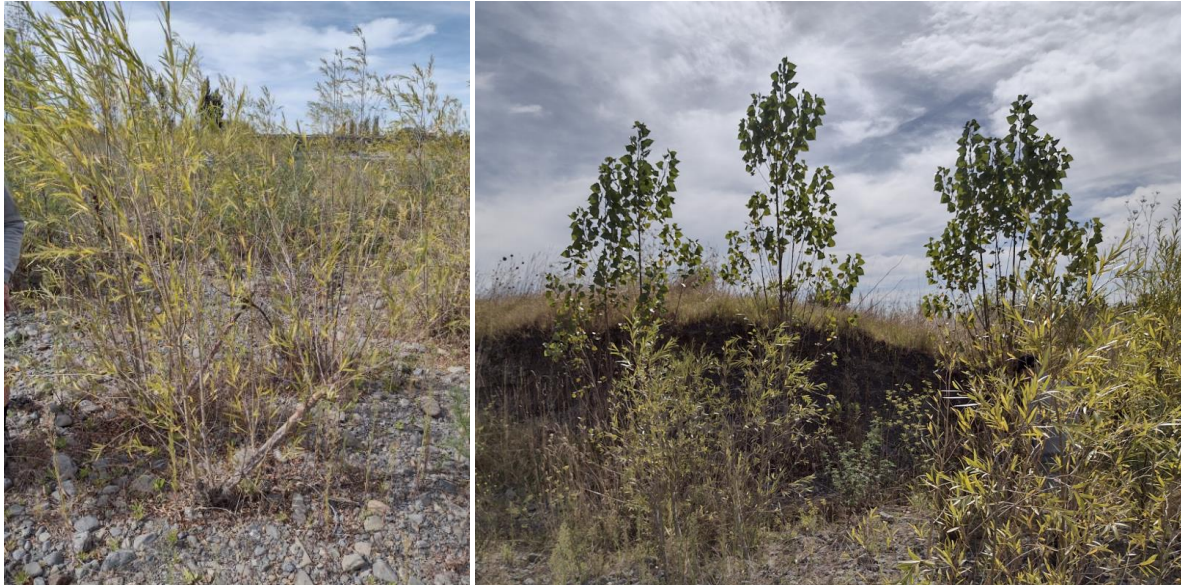
**Figure 17.** Willow and poplar growth in spite of flood damage.

Key points taken from this inspection were the surprisingly good condition of the newly planted willow poles, in spite of abrasion and breakage damage caused by floodwaters and debris. The poplar poles were in even better condition mainly because they were less exposed to flood damage. The root systems had established sufficiently to hold and prevent erosion of loose gravels. The normal approach of planting the willows closer to the water's edge, and the poplars on drier ground away from the river, proved to be successful (Figure 17). Another useful finding was how successful rope/rail groynes were in trapping woody debris, preventing local tree damage as well as downstream debris movement and related problems (Figure 18).

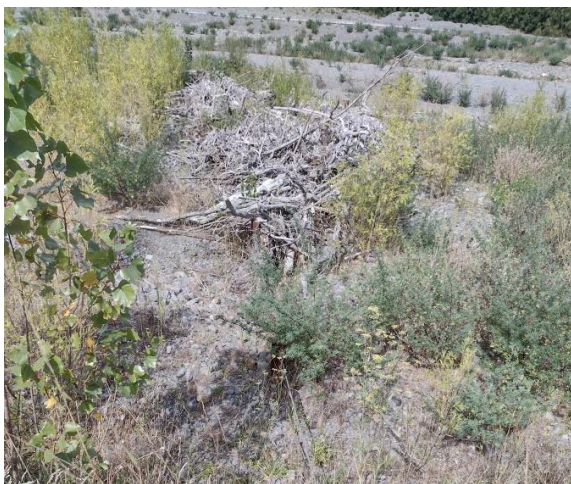
**Figure 18.** Debris capture by rope/rail groyne.

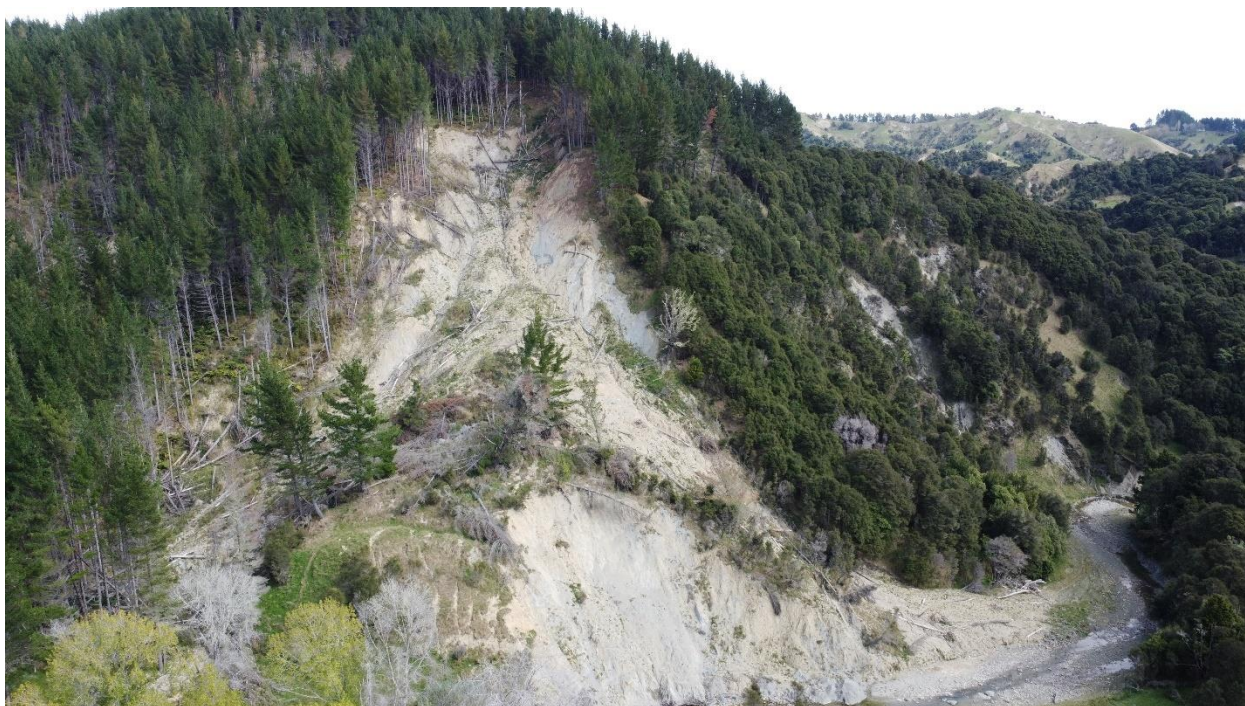
In the upper reaches, fallen plantation pine trees (falling off steep shallow soil slopes) were observed at two locations (see Figure 20). We considered that other fallen pines had been caught up in floodwaters and carried downstream to break pipe bridges along the Waingake water supply pipeline and to create blockages at bridges and bends. Mānuka-clad steep slopes did not show tree toppling (Figure 20). There was some bank erosion, mostly at sites where the bank was unprotected and had experienced erosion previously. Comparing Google images pre- and post-Gabrielle, some woody vegetation had disappeared from sloping banks in a few locations, but numbers of trees were small, and likely a mix of osier and tree willows. In the upper reaches, before the river has left the hills, floodwaters tracked over farmland, and woody debris settled on pasture, among edge trees and within the channel.

**Figure 20.** Plantation pine covered steep slope, contrasted with mānuka covered steep slopes, upper Te Ārai River.

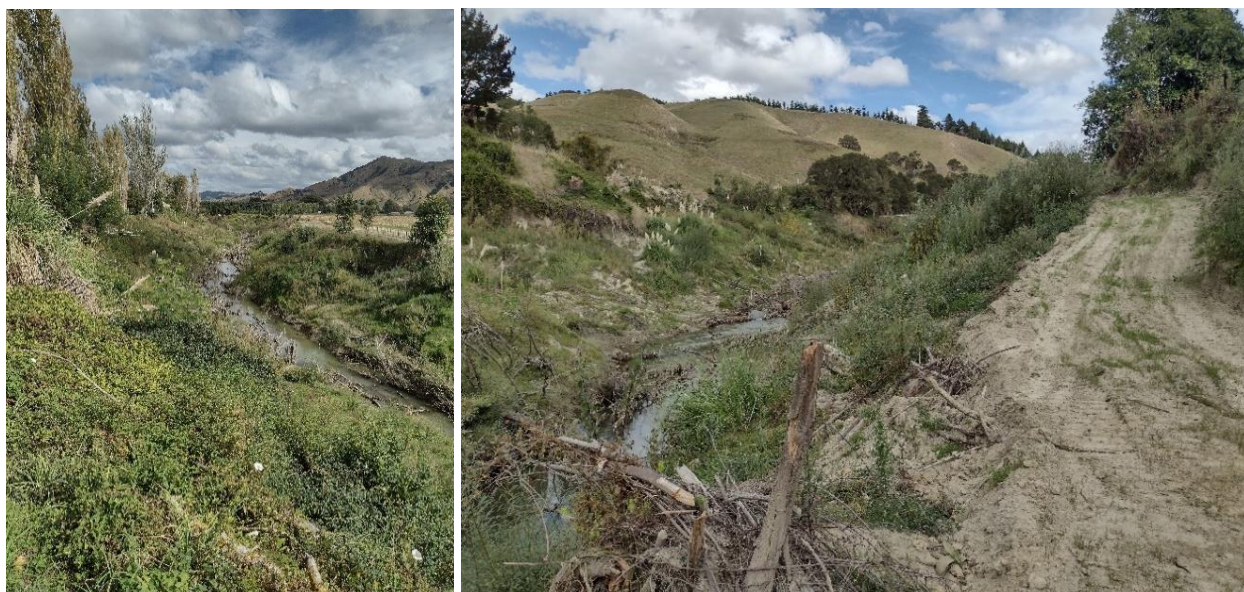
**Figure 22.** Bank edge and slope vegetation in the lower reaches of Te Ārai River, with woody debris in the channel. The access track is facilitating woody debris removal from the channel.

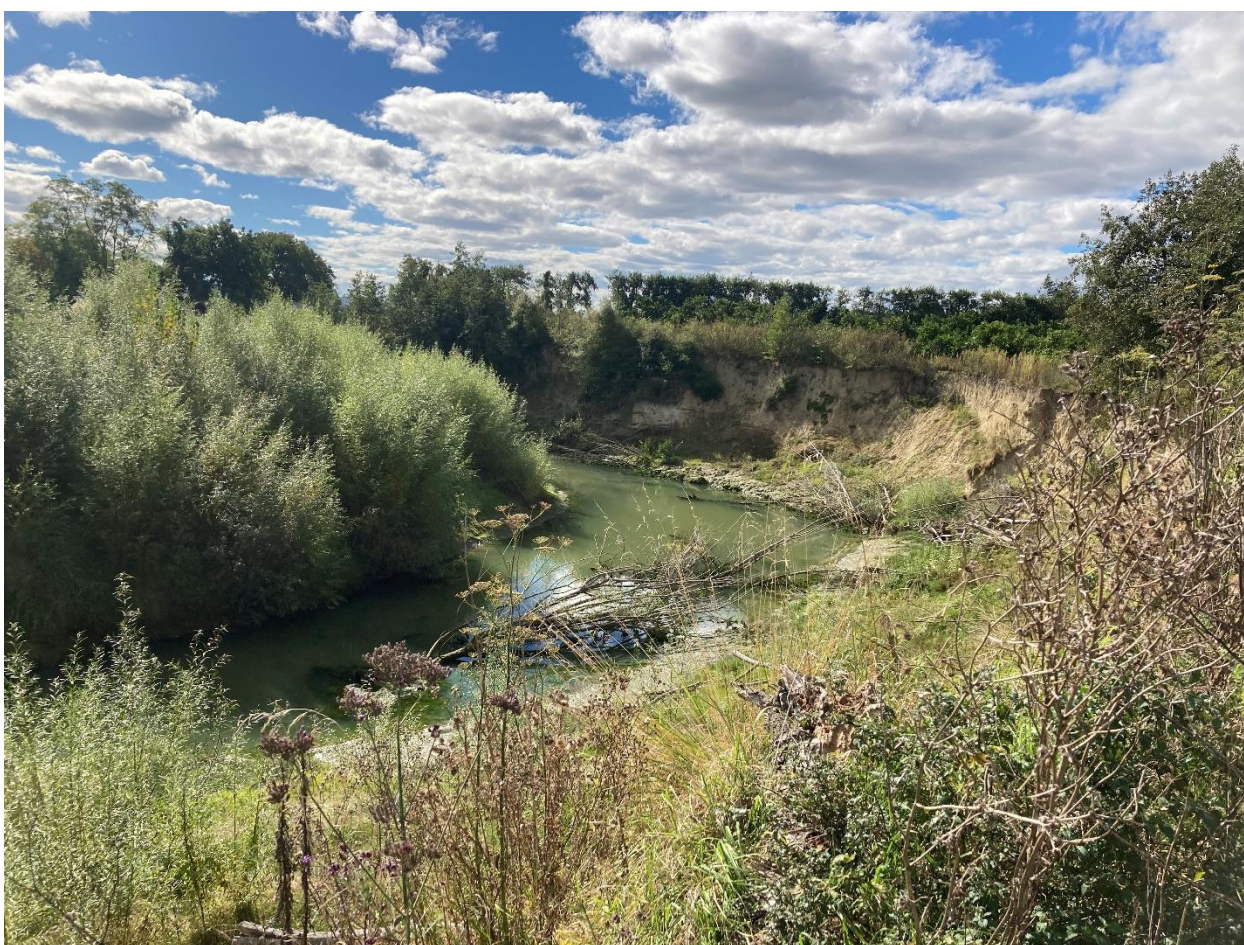
In the lower reaches, the sides of the channel were heavily silted but largely intact, with some erosion at outside corners with low protection. The bank edge showed little evidence of collapse. However, there was one outside bend where 4–5 large tree willows were missing, and at a site 200 to 300 m upstream another 3 tree willows were missing. They may have been removed intentionally by the landowner since the bank did not erode. Major channel log jams did not appear to produce erosion of the sides of the bank.

**Figure 23.** Erosion of the bank on an outside bend, Te Ārai River. Heavily wooded inside bend traps sediment and narrows the channel.

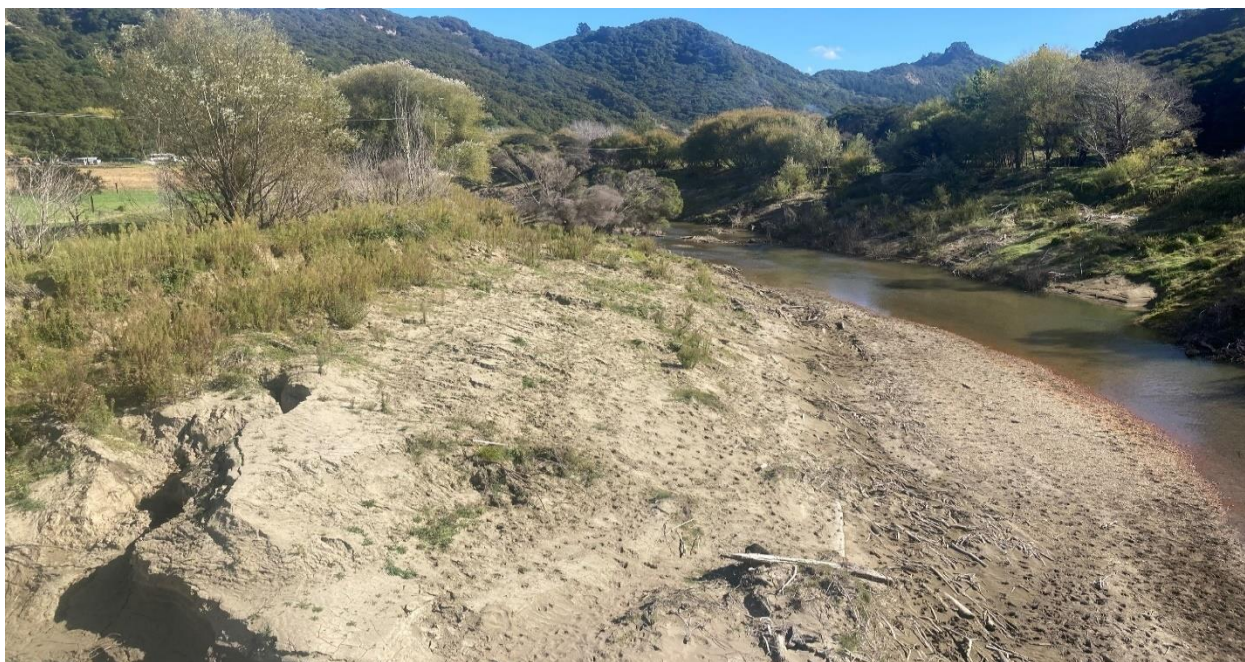
**Figure 25.** View of Hikuwai River showing stable sloping banks. Overland flow returning to the channel caused the erosion in the foreground.

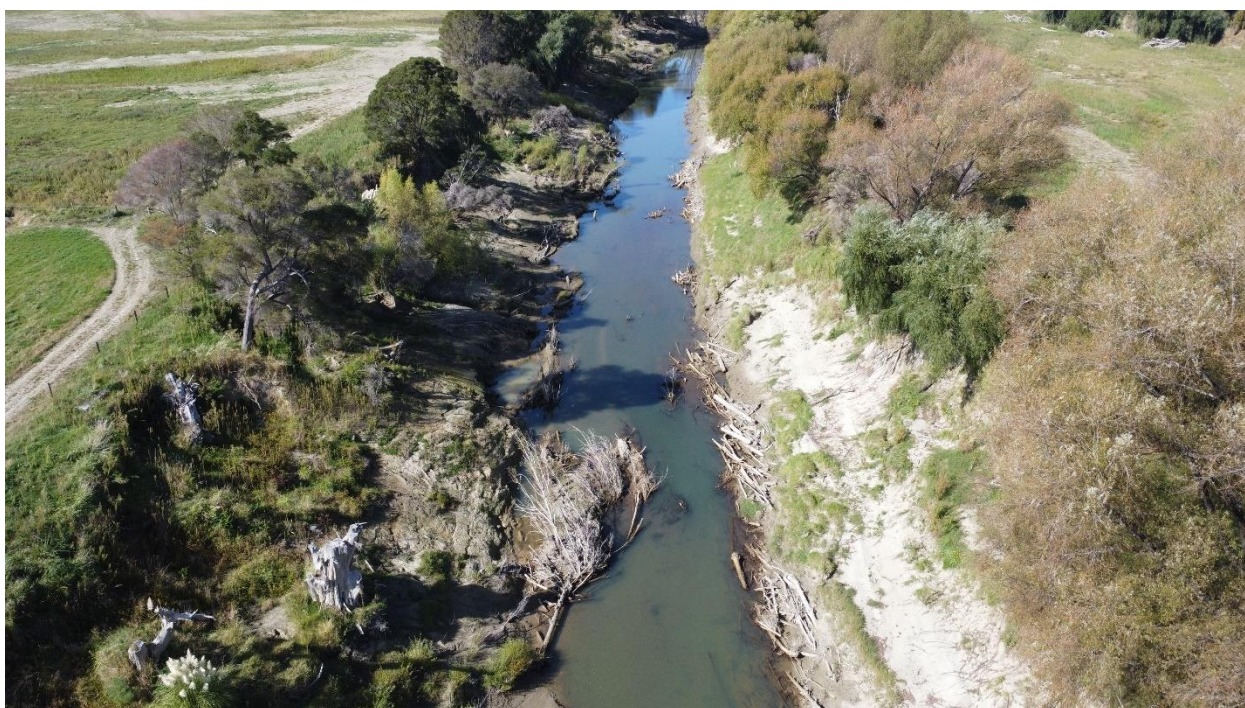
**Figure 26.** Bank stabilisation by tree willows (right bank) contrasted with slumping into the channel on left bank (despite the presence of mature mānuka and other tree species).

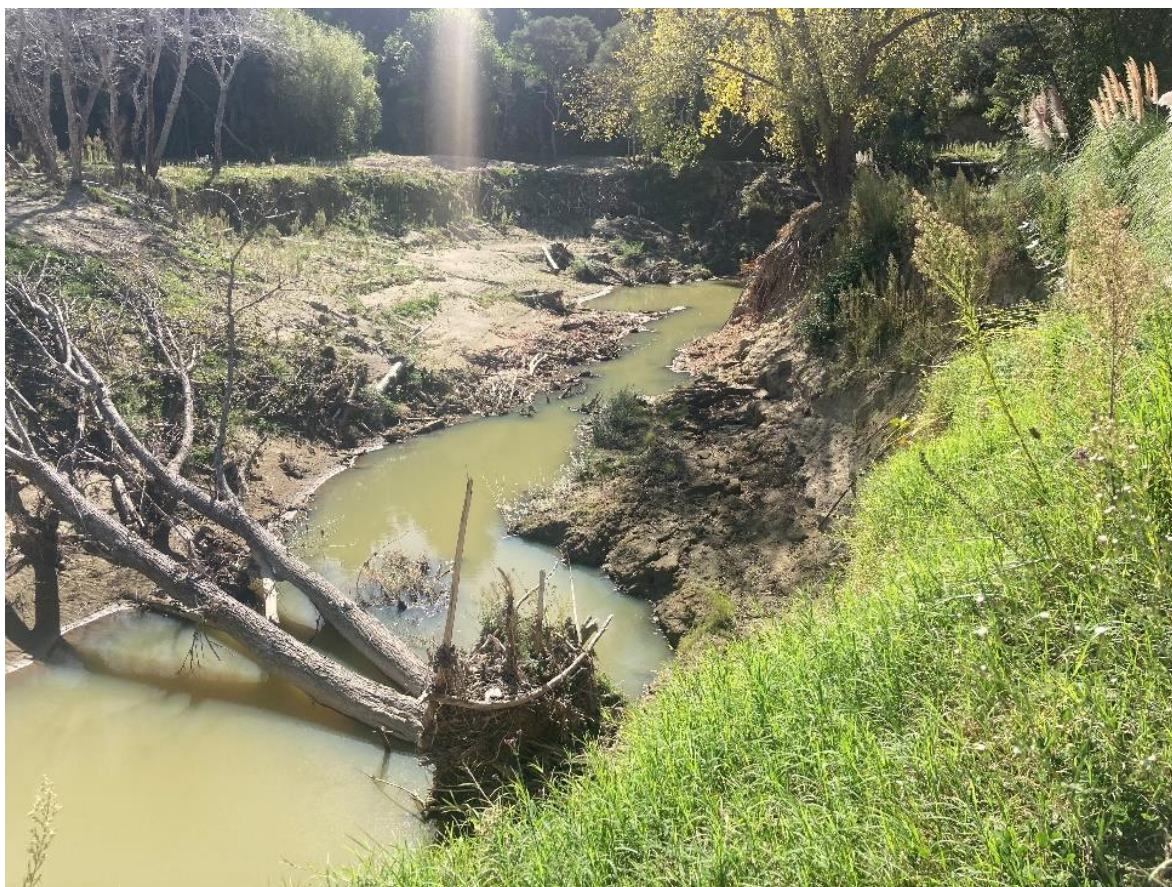
Banks on the Hikuwai River showed a high degree of stability. Where tree willows were planted at the top of the bank there was little if any slumping (Figure 24). Fibrous willow roots occupied the bank profile down to the channel. We observed large roots in the banks, partially exposed by the floodwaters, which were running laterally at different depths, and with fibrous roots extending from them (Figure 24). This was clear evidence of how willow root systems hold steep banks intact. Erosion from the top of the banks was evident where drains entered the river, and where overland flow from a low point on the paddock flowed back into the river (Figure 25). Toe erosion and slumping of the bank occurred along stretches of the river, either with no trees planted at the top of the bank, or where unsuitable trees (mānuka, poplar, tōtara) were undermined (Figure 26). At several locations, we observed that poplars planted on the top of the bank, and close to edge, were undermined and toppled by floodwaters. One example was at Hikuwai No. 1 Bridge (Figure 27).

**Figure 27.** *Populus x euramericana* poplar undermined by floodwater above No. 1 Bridge, Hikuwai River.

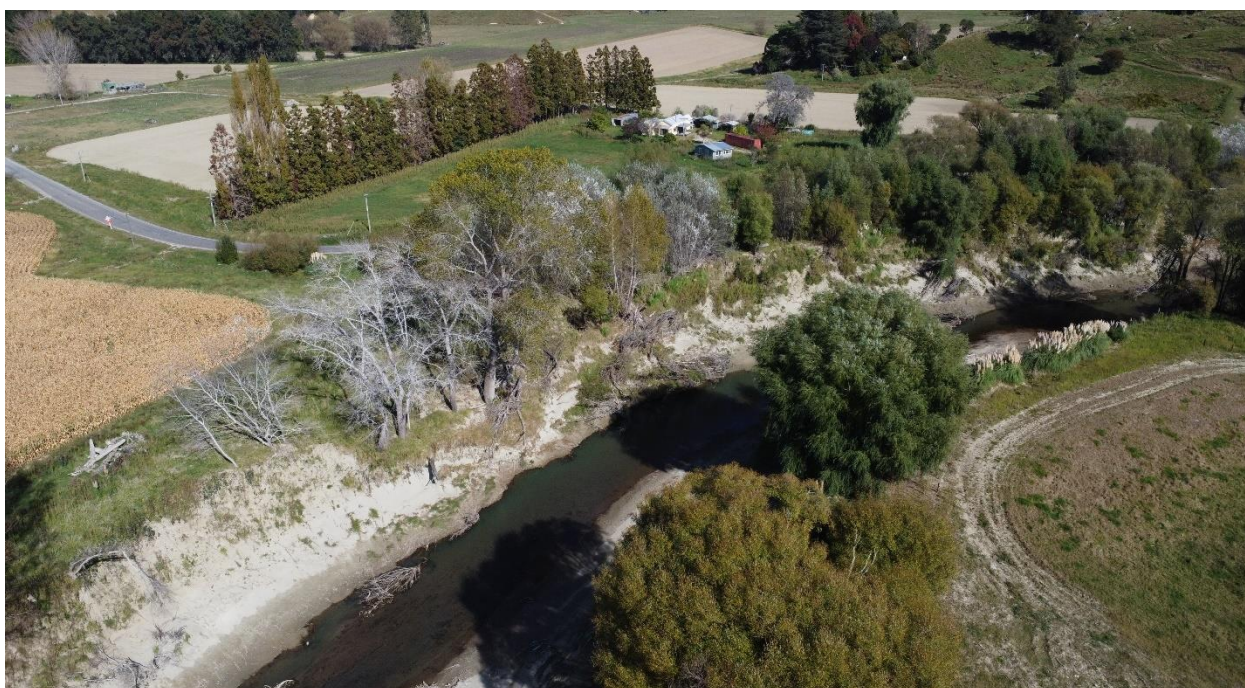
Outer bends which were well planted with trees showed little erosion, whereas outer bends devoid of trees lost sediment at the top and sides of the banks (Figures 28 & 29).

**Figure 28.** Densely treed outer bends suffered little bank erosion, but silver poplars (foreground, left bank) were undermined by toe erosion.

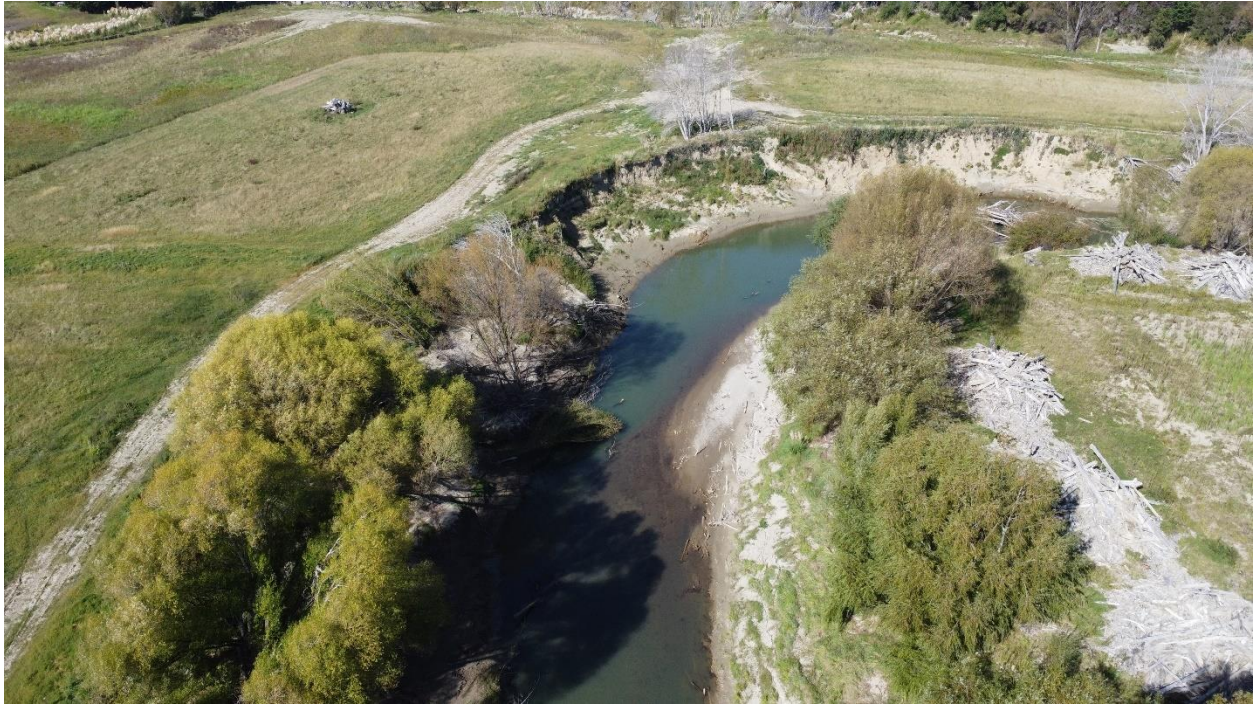
**Figure 29.** Sparsely treed outer bends showed more toe erosion and slumping.

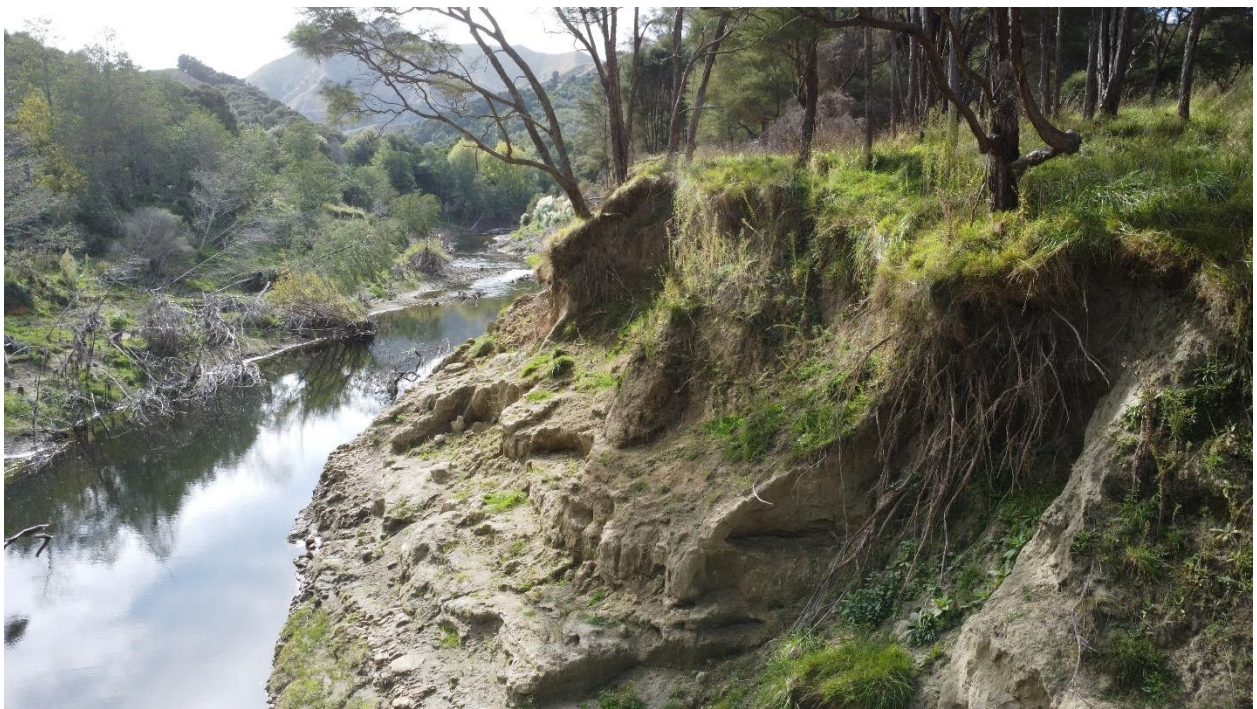
**Figure 31.** Mānuka roots exposed by bank erosion, Waimatā River. Poplars on opposite side partially destabilised by floodwaters.

**Recommendation – woody plantings intended for bank stabilisation along rivers must have adequate root systems to bind sediment.**

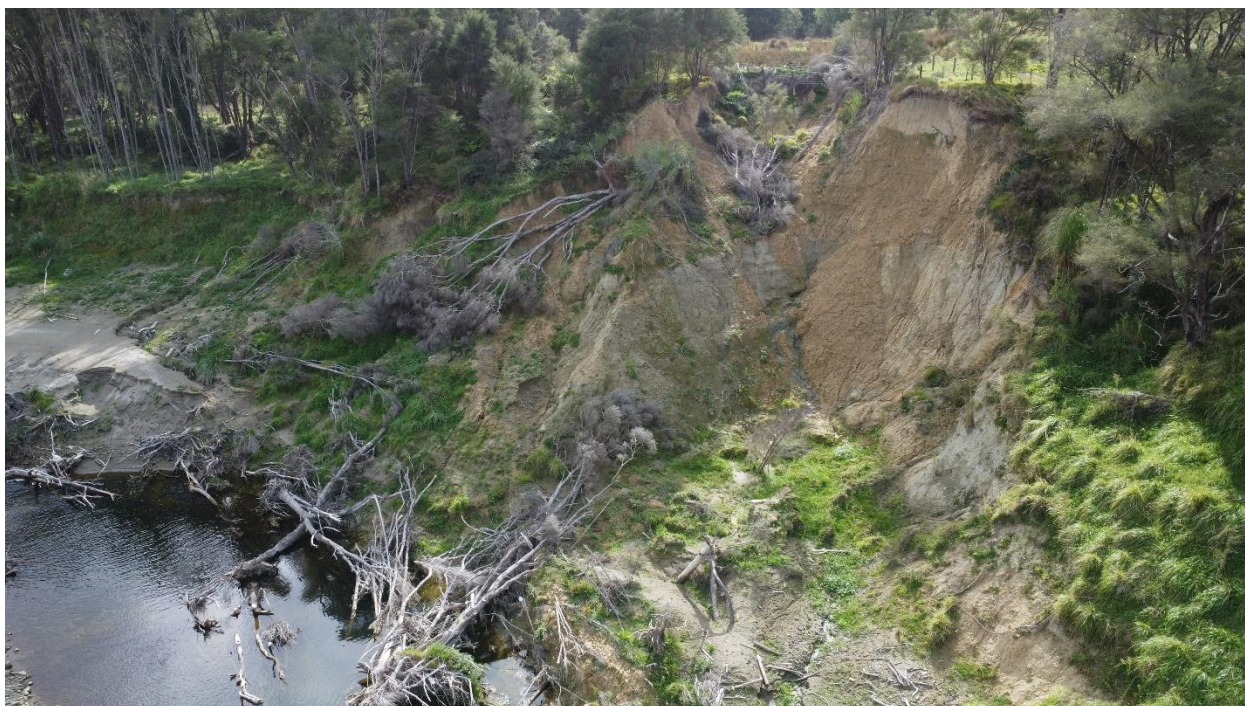
**Figure 32.** Mānuka trees toppled by gullyng of a stream running into Waimatā River.

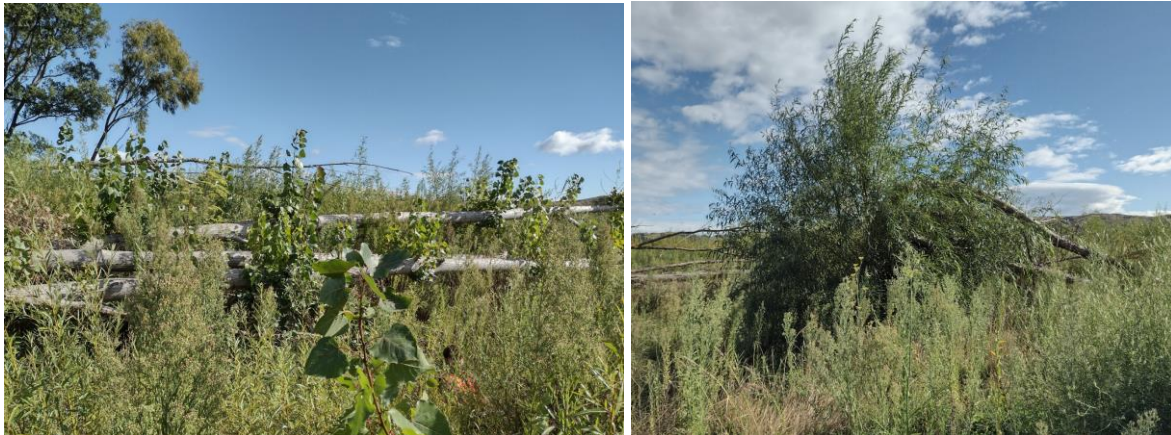
**Figure A10.** Regrowth under debarked poplar (left). Layered & partially debarked willow regrowth (right).

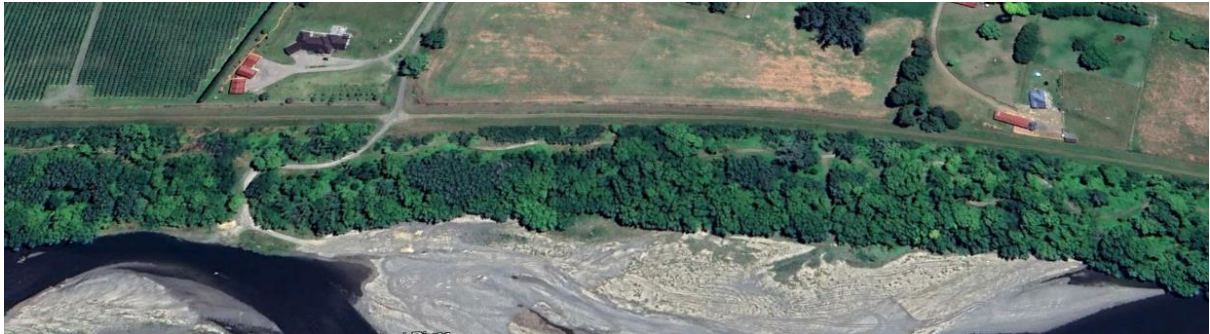
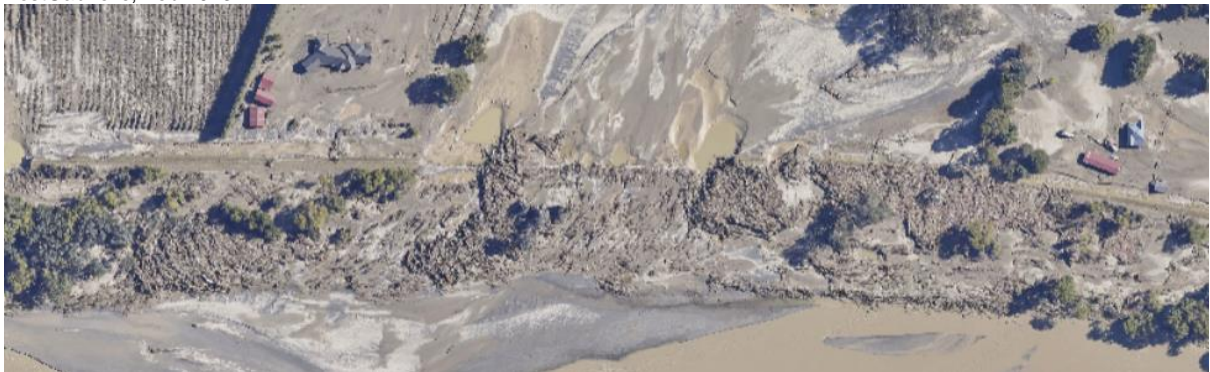
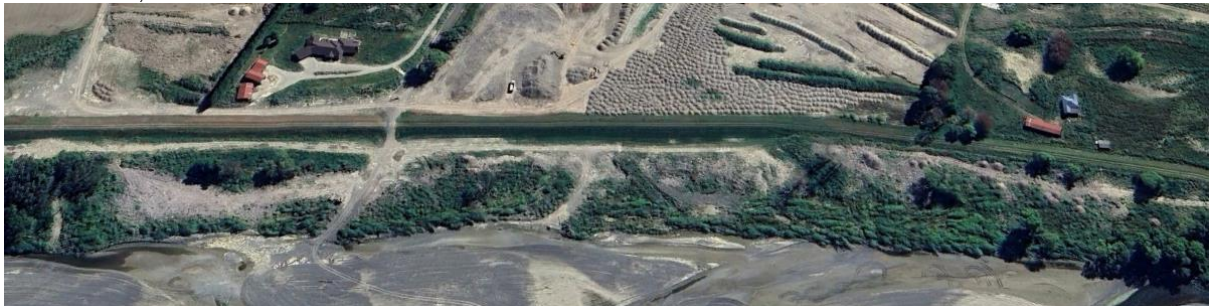
**Figure A11.** Directional effect of Ebbetts floodplain return flows & Dartmoor stopbank breach flows.

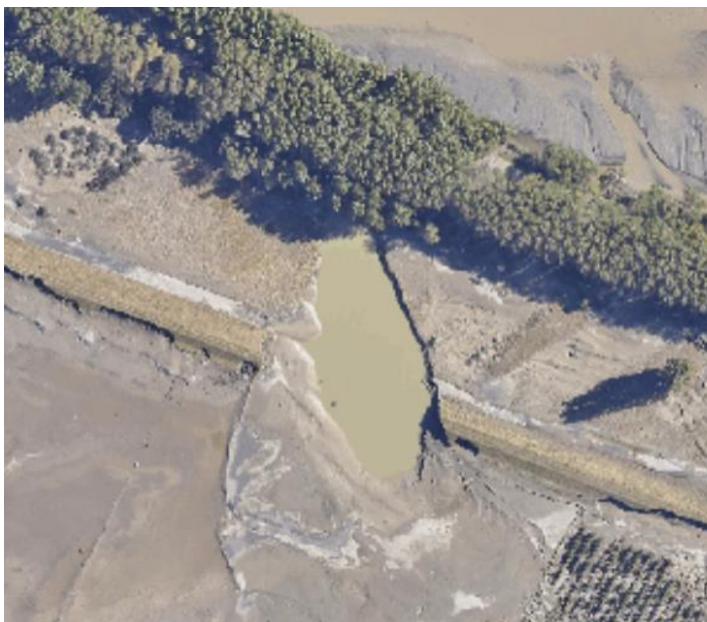
**Figure A15.** Moteo stopbank breach – berm scour arrested by buffer zone.

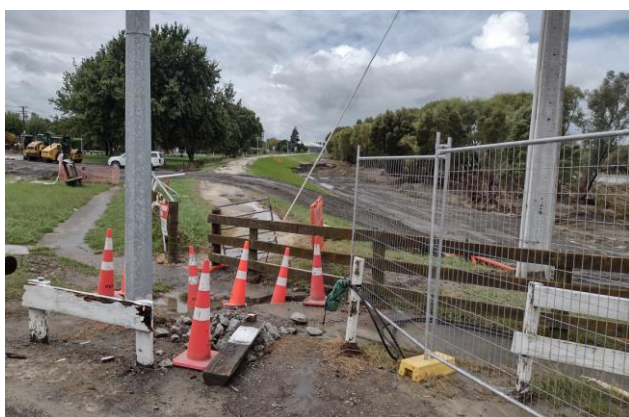
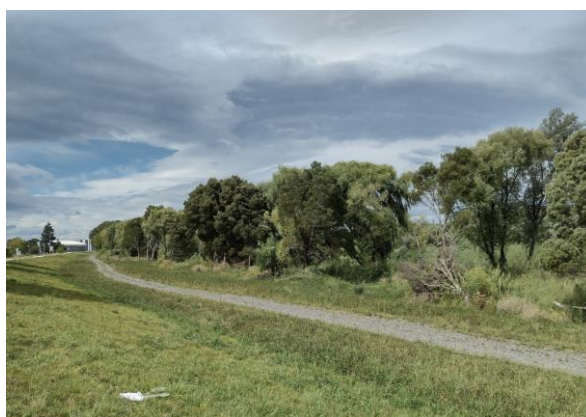
**Figure A21.** Berm erosion alongside Taradale stopbank (left). Taradale stopbank – post-cyclone berm repairs (right).

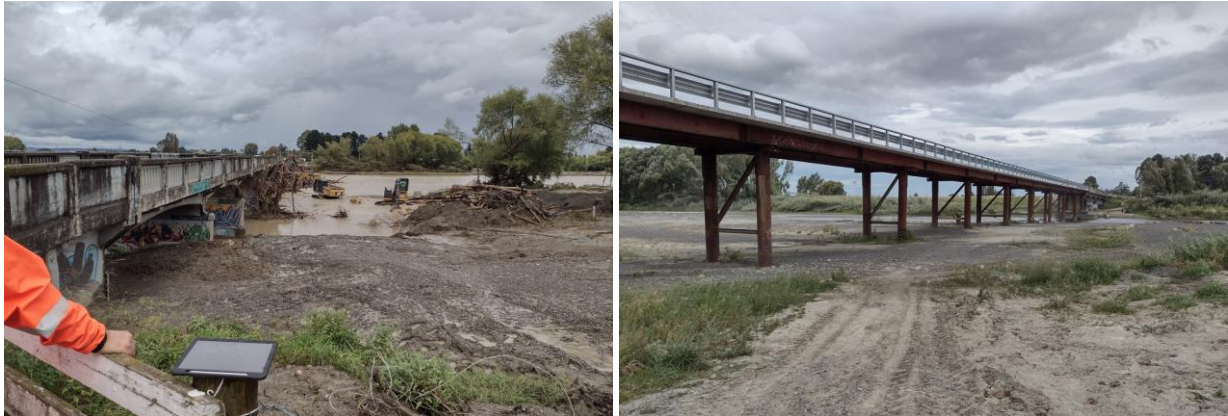
**Figure A22.** Redclyffe Bridge – cyclone debris removal (left). Redclyffe Bridge – interim repairs (right).

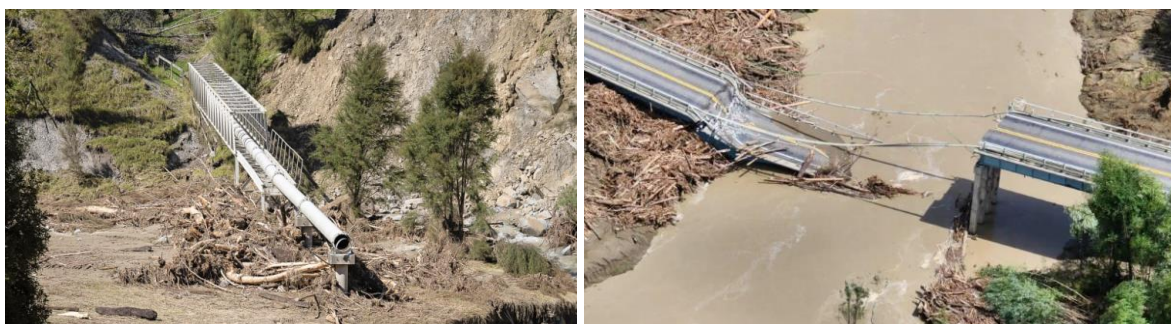
Plantation forestry (*Pinus radiata*) contributed large volumes of woody debris into waterways such as the Ūawa-Hikuwai and Te Ārai Rivers. Although waterways and bridges were largely cleared of Cyclone Gabrielle woody debris at the time of inspection, the team saw evidence of mature pine trees, as well as pruning/thinning waste, being carried downstream and deposited within the river channel, on bridges, and over floodplains. Woody debris contributed to the wash-out of pipe bridges along the Waingake water supply pipeline to Gisborne City (Figure A23 left) , as well as collapse of the Hikuwai River No. 1 Bridge (Figure A23 right).

**Figure A23.** Damaged Gisborne water supply pipeline & Hikuwai No.1 Bridge.

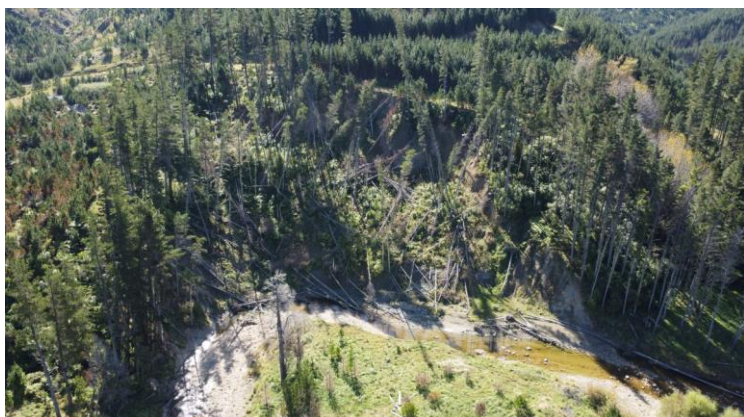
**Figure A24.** Major slip carrying mature pine trees into the river bed – Hikuwai catchment.

Modification of forestry practices to avoid tree planting or the stockpiling of forestry waste on unstable slopes and close to waterways will help reduce woody debris problems. In the upper Te Ārai and Hikuwai catchments there were hill slopes that had failed, carrying whole trees downslope into the river channel (Figures A24 & A25). Locations nearby with comparable slopes, and recently regenerated native vegetation, appeared to be more stable (Figure A26). If these slopes were to fail, the slower growing native vegetation would contribute less woody debris of smaller size than plantation forestry.

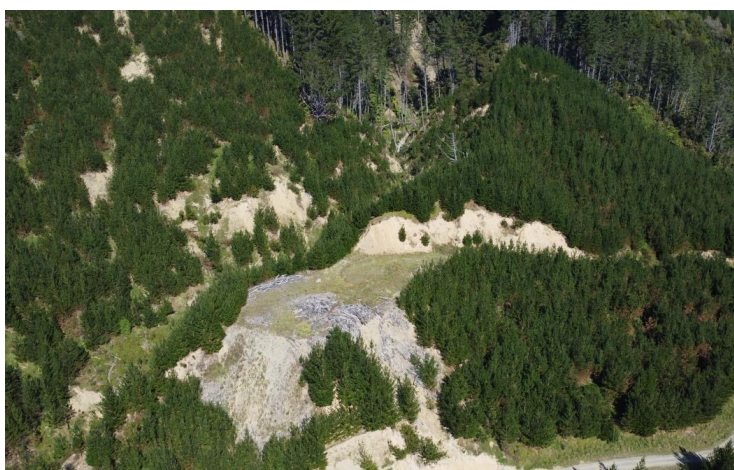
**Figure A25.** Forestry landing and woody waste pile undermining – Hikuwai catchment.

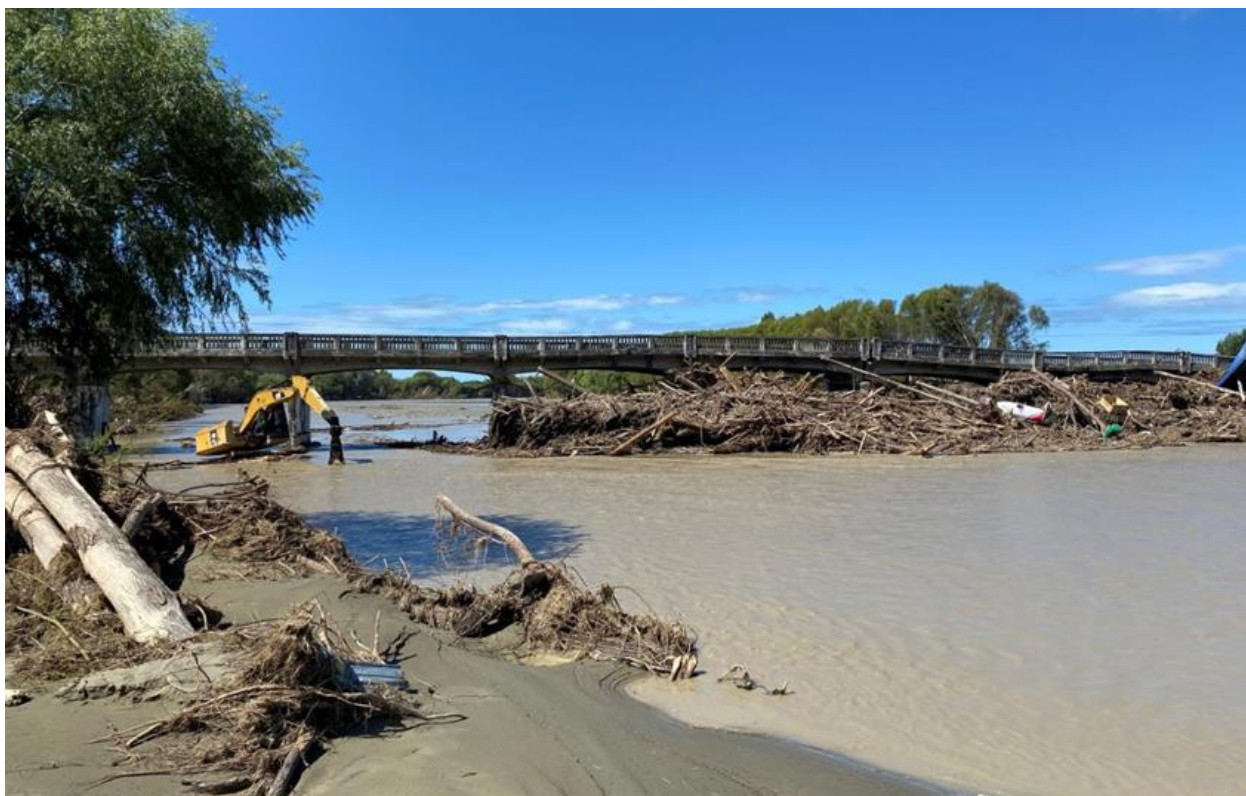
**Figure A36.** Woody debris on collapsed Redclyffe Bridge.
