PFR SPTS No. 25684

## **Poplars and willows as bioengineering solutions for riverbank flood protection – learnings from Cyclone Gabrielle**

Mclvor I, Heslop I, Brooks F

June 2024

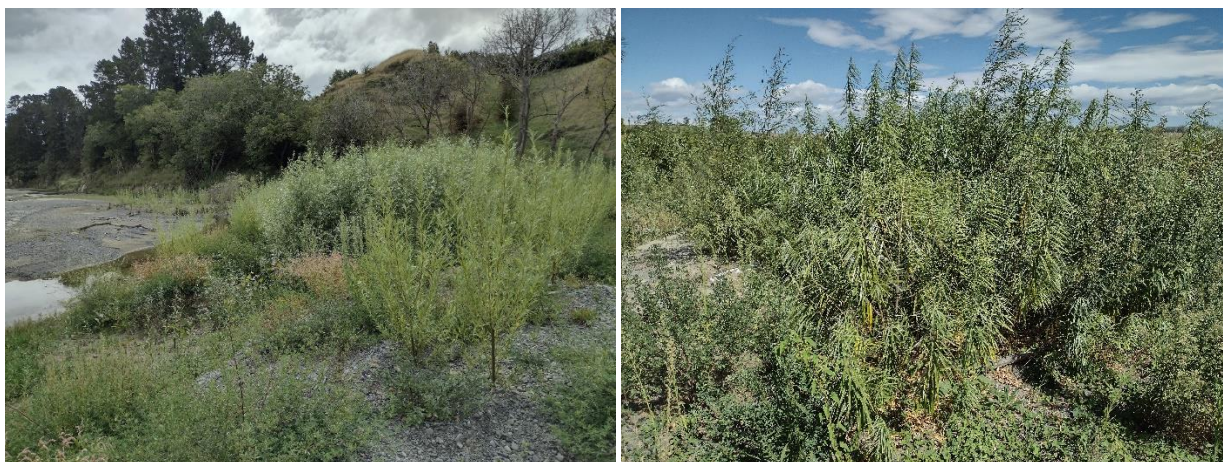
Poplars are used to add protection behind tree willows at higher elevation (Figure 6). Poplar root systems do not have the fibrous root arrangement seen in willows, and are not tolerant of prolonged submergence in water. Poplar root systems are extensive (like tree willow root systems), and grow laterally, vertically, and obliquely at different depths. They are excellent for soil binding in the zones that are only periodically flooded. Poplars are larger trees than willows at maturity. Willows and poplars establish readily in gravel sediments when planted as poles down to the water table (Figure 5).

**Figure 5.** Willow pole growth after one season compared with shoot growth from a layered tree willow, located immediately behind and upstream of the poles, and installed simultaneously (left). Osier willow (*S. viminalis*) on the river edge (right).

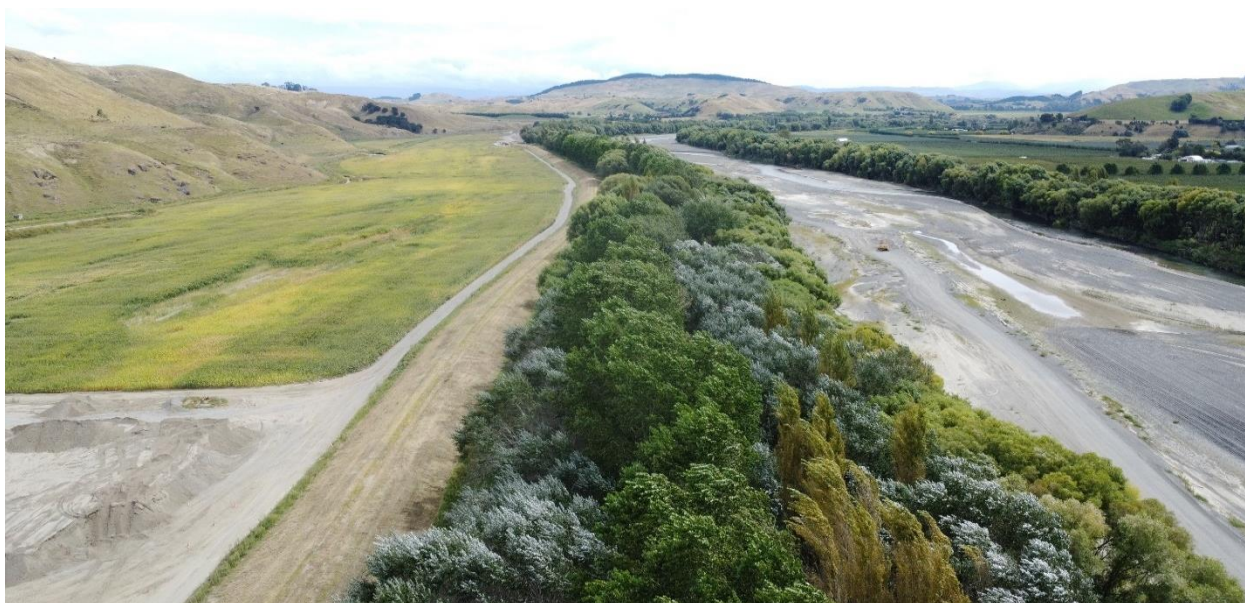
**Figure 6.** Live edge protection along the Tūtaekurī River. The front edge willows are supported by rows of different poplar cultivars behind.

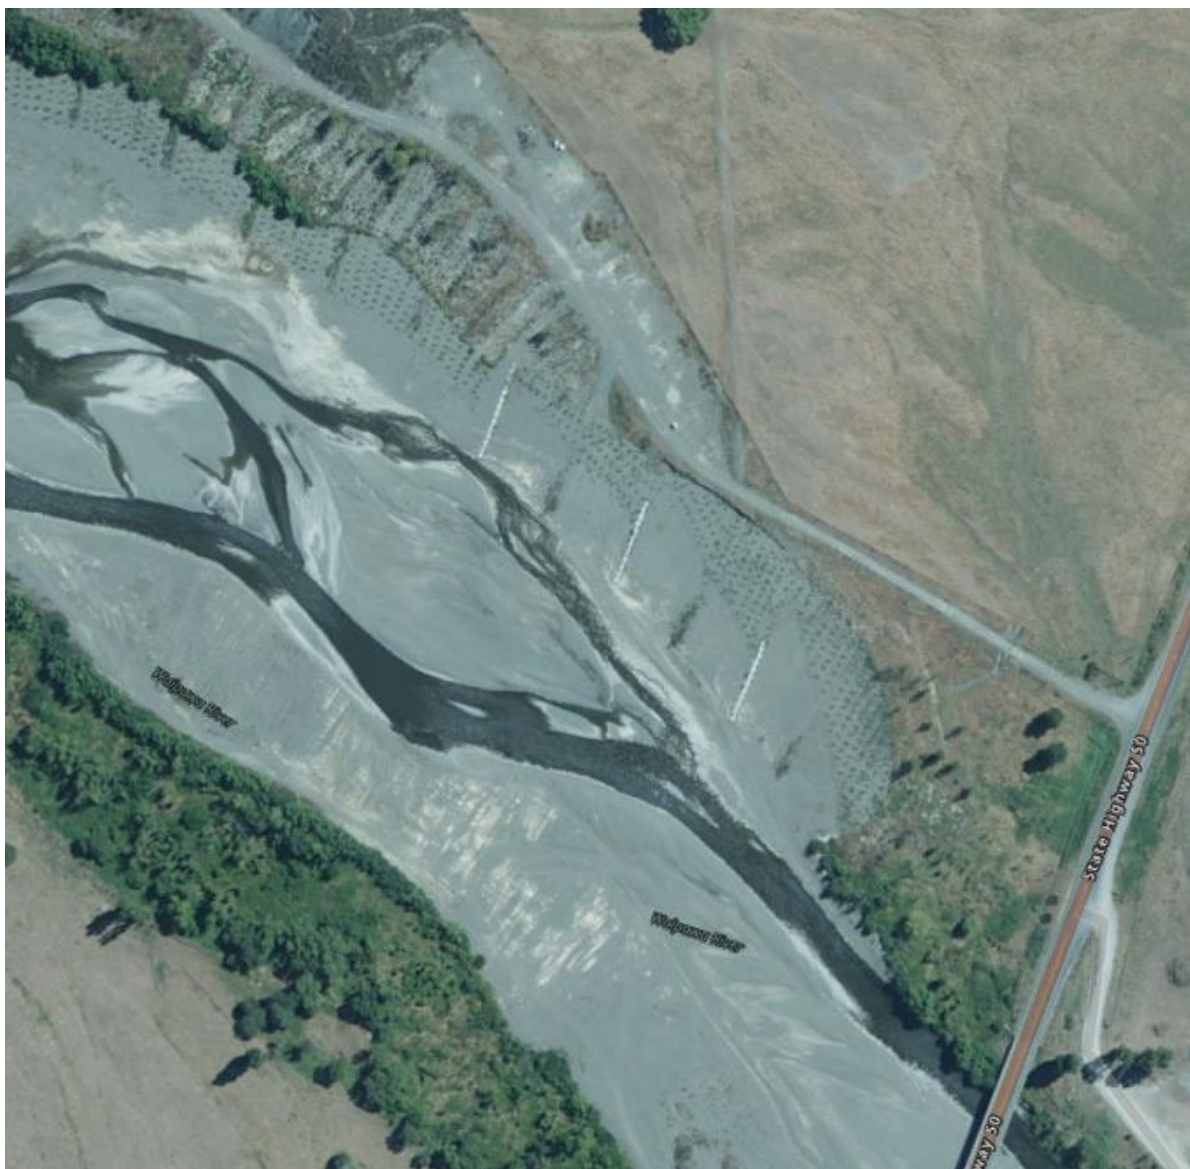
A comprehensive project was undertaken upstream of SH50, and just prior to Cyclone Gabrielle, to secure the channel alignment and prevent damage to the SH50 Bridge. Works consisted of channel realignment, erosion bay infill, Akmon groynes, rope/rail groynes & training lines, and extensive tree planting (Figure 15). Infilled gravel areas closer to the river were planted with willow poles (*Salix matsudana x alba* hybrids), and poplar poles (*Populus x euramericana* 'Veronese') were planted higher up on the banks. Cyclone Gabrielle partially undermined the Akmon and rope/rail groynes causing bank erosion and channel realignment (Figure 16). A further flood in June 2023 further damaged these works upstream of SH50, resulting in bridge abutment wash-out and road closure.

**Figure 15.** Newly completed Waipawa River training works upstream of SH50 – prior to Cyclone Gabrielle.

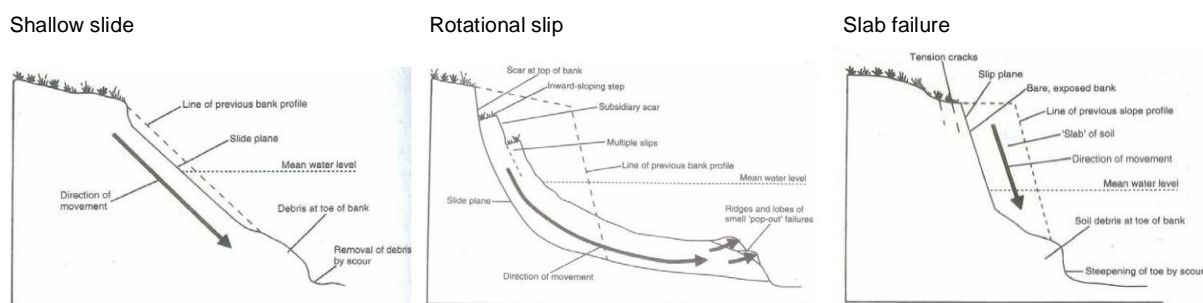
An understanding of the mechanism of bank erosion and/or instability is important to help determine the appropriate bioengineering method. Figure 19 shows several possible bank instability modes demonstrated in the Te Ārai (as well as the Ūawa-Hikurangi and Waimatā Rivers). The mechanism of bank saturation during flood (adding weight, increasing soil pore water pressures, and lubricating slip surfaces), toe erosion (especially on the outside of bends), and flood recession (removal of stabilising hydrostatic pressure) – all contribute to riverbank slope failures. These rivers have high suspended sediment loads, and deposit silts on the banks during quiet flood sequences, thus healing the slope failures and shrinking channel capacity. Riverbank toe erosion, slope failure, and channel enlargement during the next major flood repeats this natural cycle.

**Figure 19.** Riverbank slope failure modes.

**Recommendation – establish osier willows on the outside of bends, with a combination of tree and osier willows (or other bioengineering methods) on outside bends where erosion or slumping is threatening roads, high value farmland, or other valuable assets.**

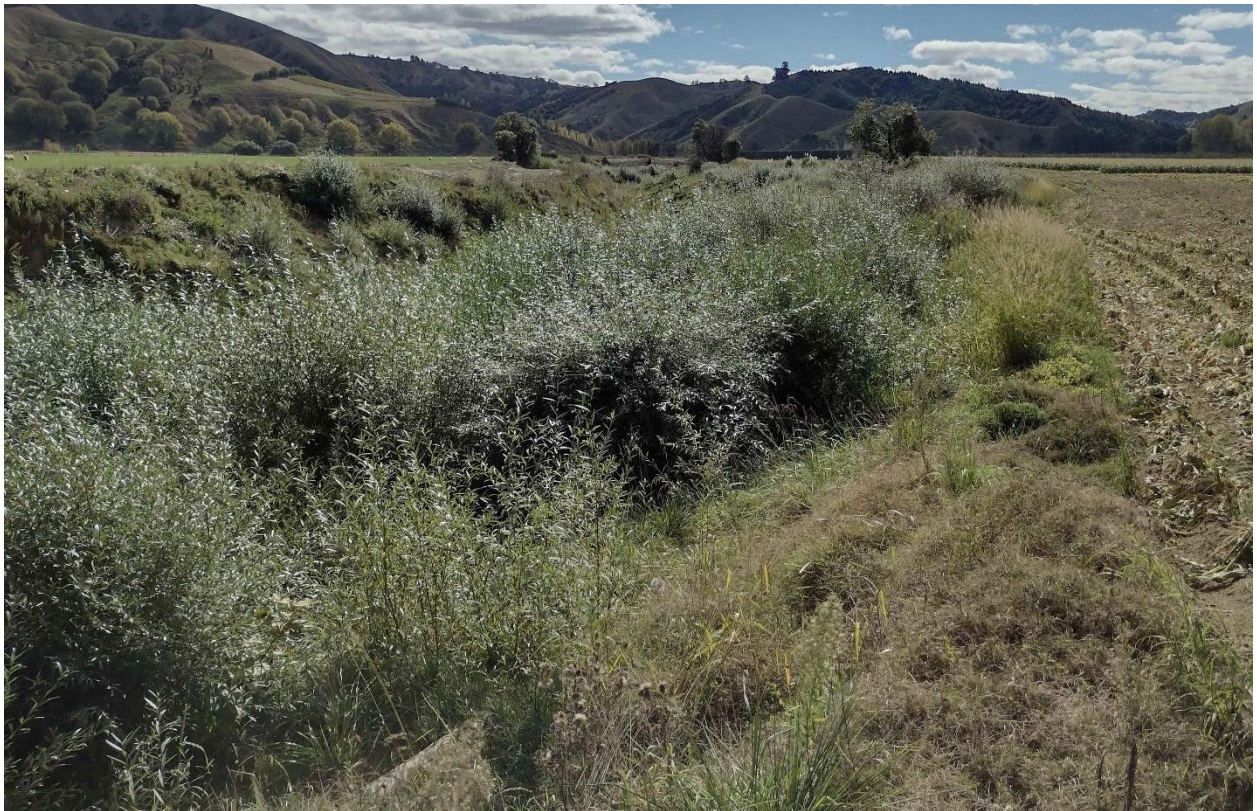
Except for a few sites, the river edges and bank were intact and protected by mature woody vegetation (Figure 21). Woody debris trapped in the channel had been removed, and the woody vegetation (largely osier willow) had been coppiced (Figure 22). Eroded outside bends had not yet been re-stabilised (Figure 23). There was no evidence of trees being flattened by floodwaters as noted on the Tūtaekurī River. This was no doubt attributable to the lower gradient and flood velocities in the Te Ārai River.

**Figure 21.** Typical bank vegetation on downstream Te Ārai River with dense osier willow on near bank.

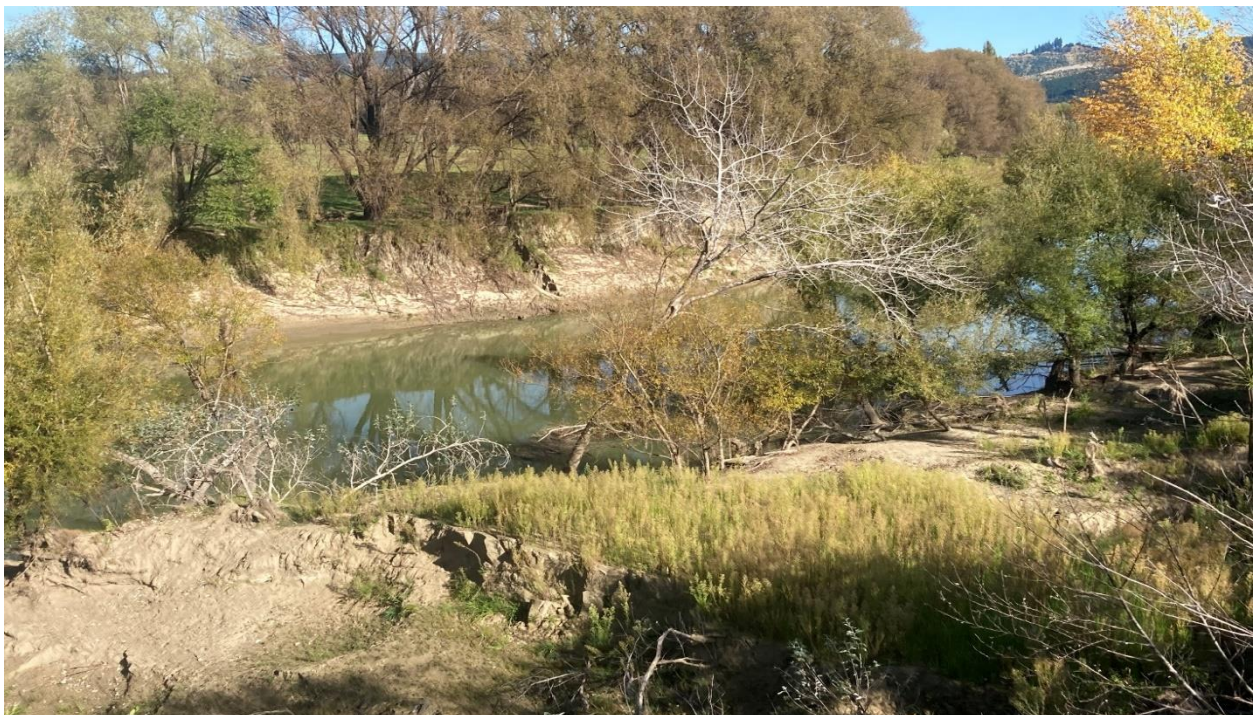
Banks on the Hikuwai River showed a high degree of stability. Where tree willows were planted at the top of the bank there was little if any slumping (Figure 24). Fibrous willow roots occupied the bank profile down to the channel. We observed large roots in the banks, partially exposed by the floodwaters, which were running laterally at different depths, and with fibrous roots extending from them (Figure 24). This was clear evidence of how willow root systems hold steep banks intact. Erosion from the top of the banks was evident where drains entered the river, and where overland flow from a low point on the paddock flowed back into the river (Figure 25). Toe erosion and slumping of the bank occurred along stretches of the river, either with no trees planted at the top of the bank, or where unsuitable trees (mānuka, poplar, tōtara) were undermined (Figure 26). At several locations, we observed that poplars planted on the top of the bank, and close to edge, were undermined and toppled by floodwaters. One example was at Hikuwai No. 1 Bridge (Figure 27).

**Figure 24.** Willows lining the top of the bank, with roots visible down the sloping bank to the channel, Hikuwai River.

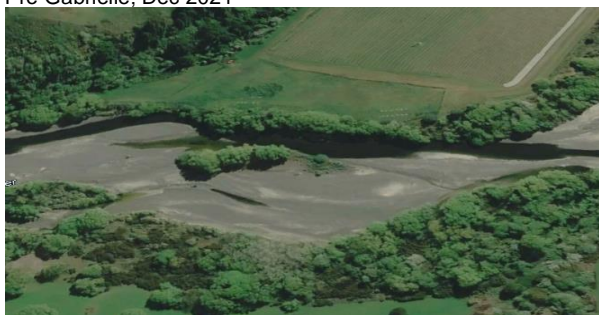
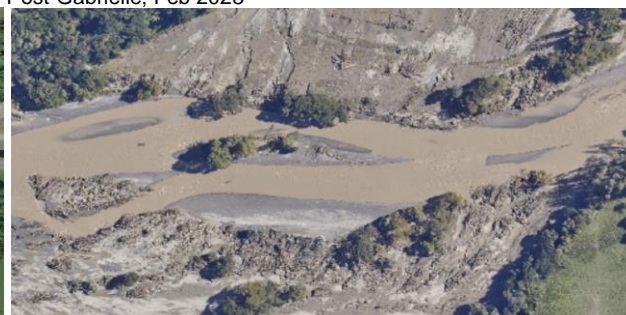
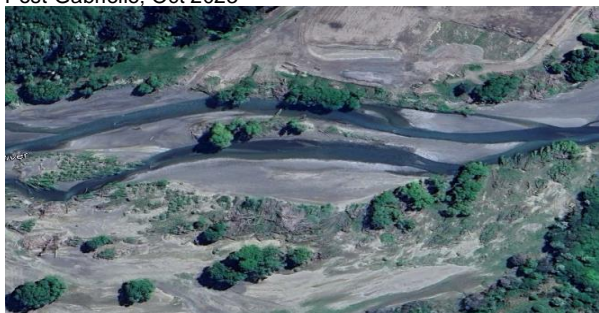
**Figure A1.** Aerial photos – upstream of Mangaone confluence.

The site visit showed strong regrowth of layered or partially undermined bank and berm willows. The river channel and floodplain areas had been cleared of woody debris, which was carted away for processing, or chipped on site. The wider buffer plantings showed especially high resilience with minimal damage. There was substantial filtering and trapping of woody debris, which was especially obvious on post-Gabrielle aerial photos at the downstream end of the vineyard.

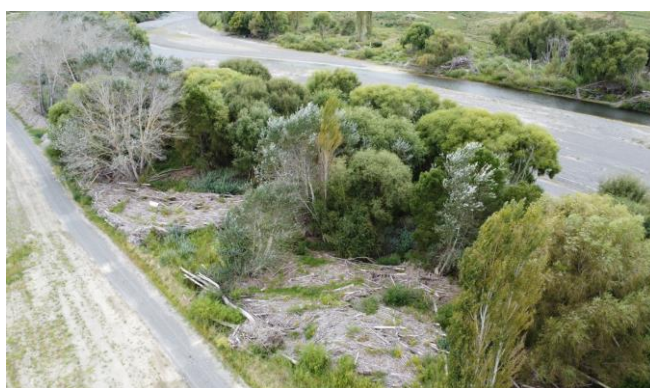
Buffer zone with trapped woody debris.

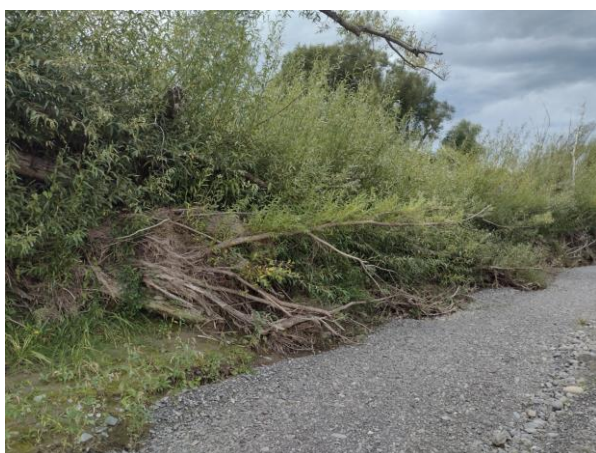
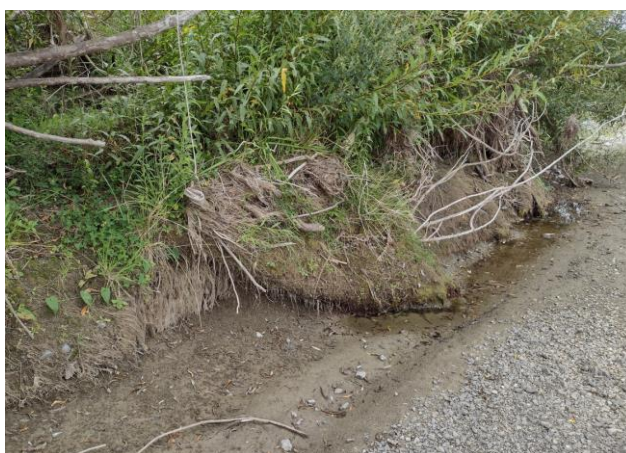
**Figure A4.** Flood layered willows & willow root mat healing bank erosion.

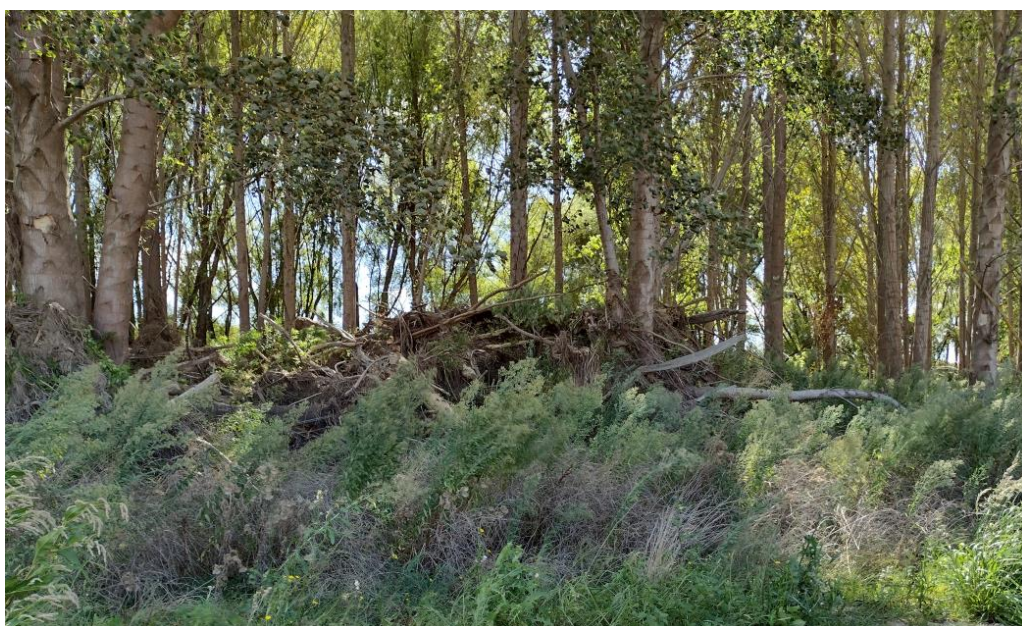
**Figure A9.** Woody debris capture in buffer zones.

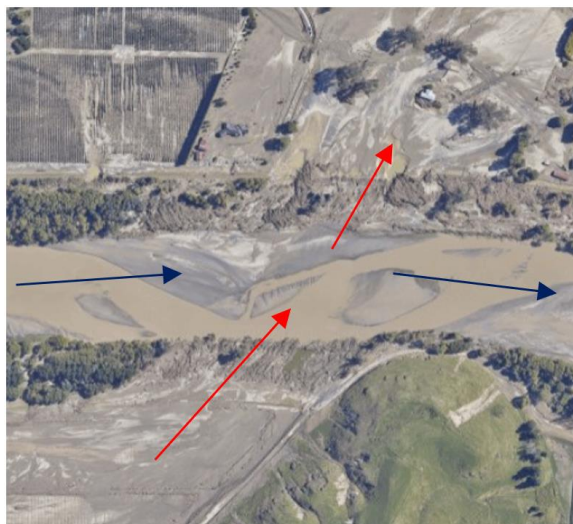
**Figure A12.** Directional flow of floodwater from Ebbetts across the channel to lower Dartmoor.

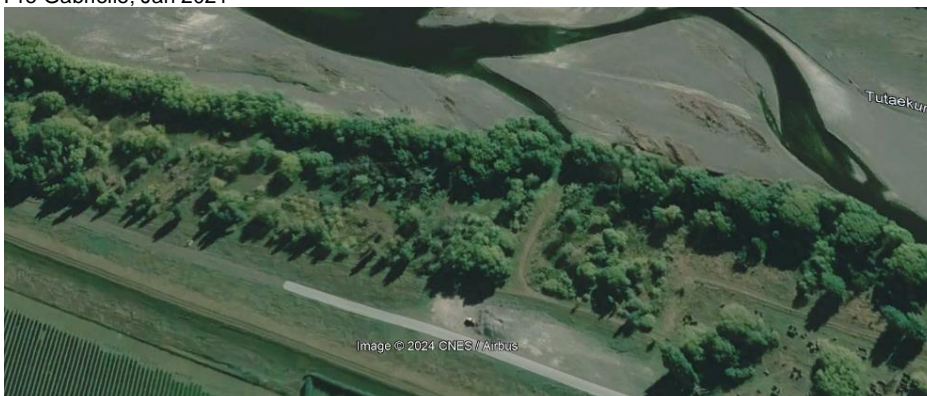
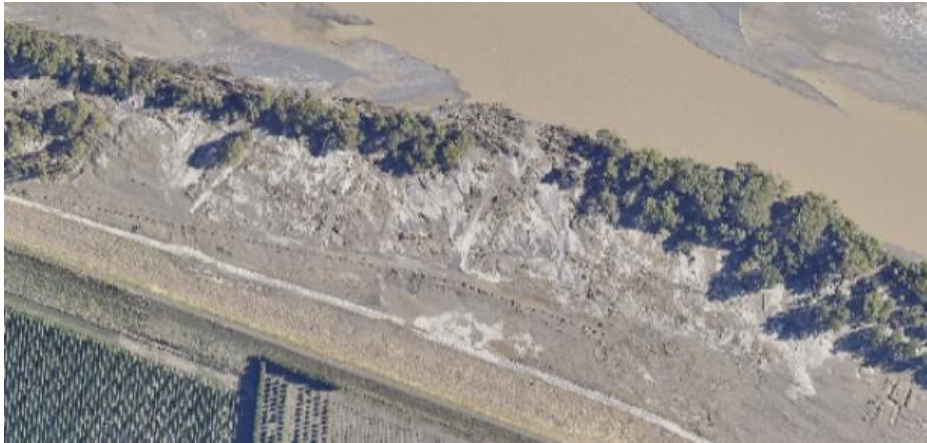
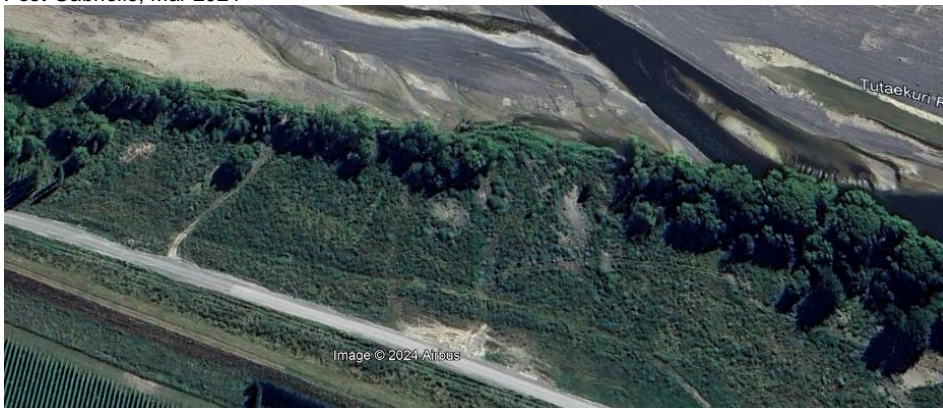
**Figure A14.** Aerial views of the Moteo site pre- and post-Gabriel.

Of particular note was the effectiveness of the buffer zone, adjacent to the major Moteo stopbank breach, in preventing the berm scour hole from connecting with the river channel. Such a connection would have increased berm and stopbank flood damage and resulting damage to floodplain property.

Overall, the buffer plantings upstream and downstream of the site were in very good condition and showed exceptional resilience to the flood event.

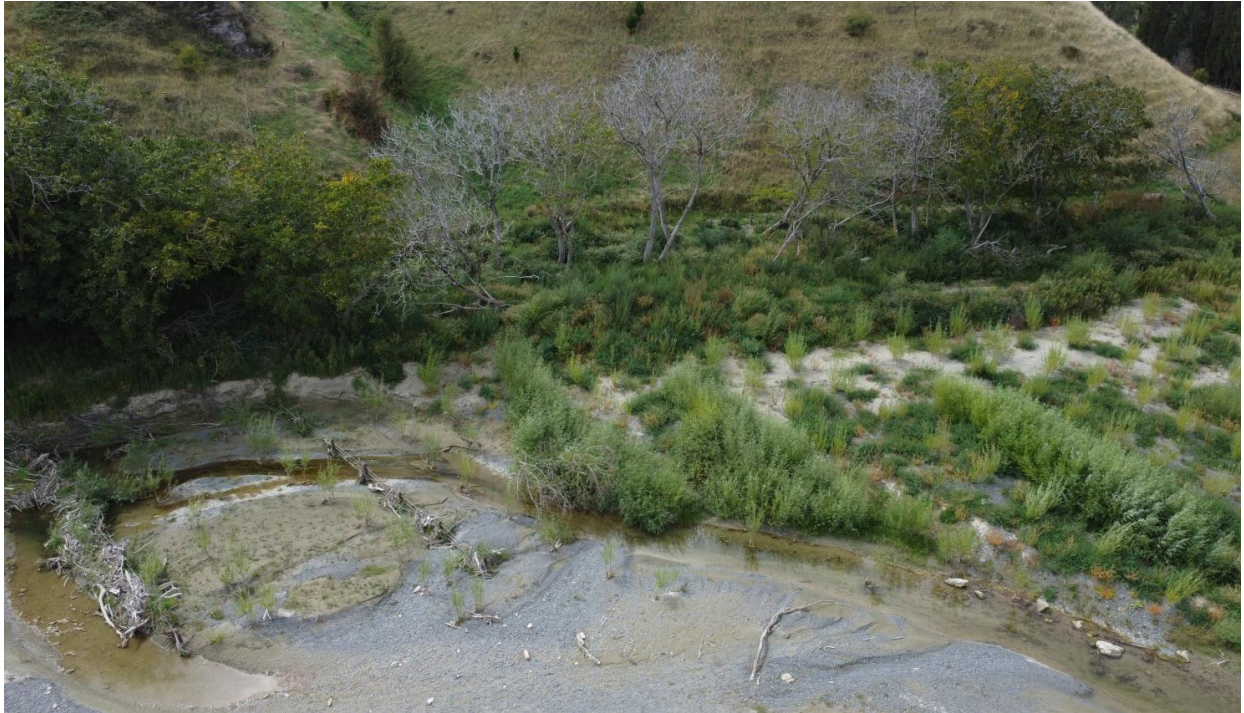
**Figure A17.** Rope & rail groynes, willow trenching, and pole planting.

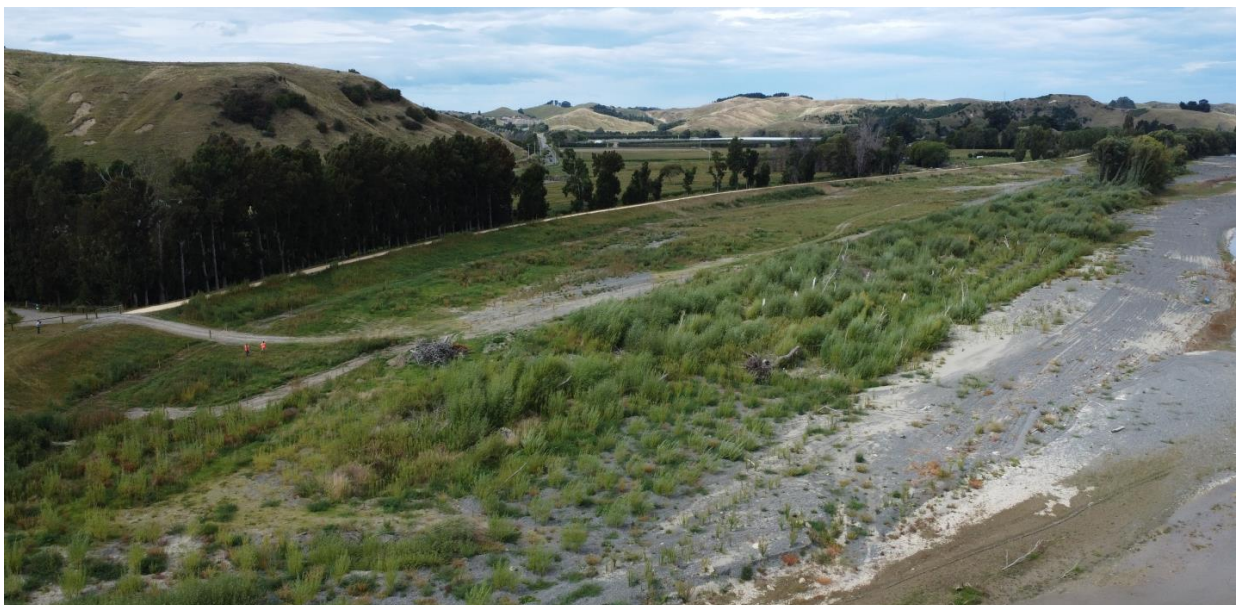
**Figure A18.** Flood layered willow regrowth & pole planting.

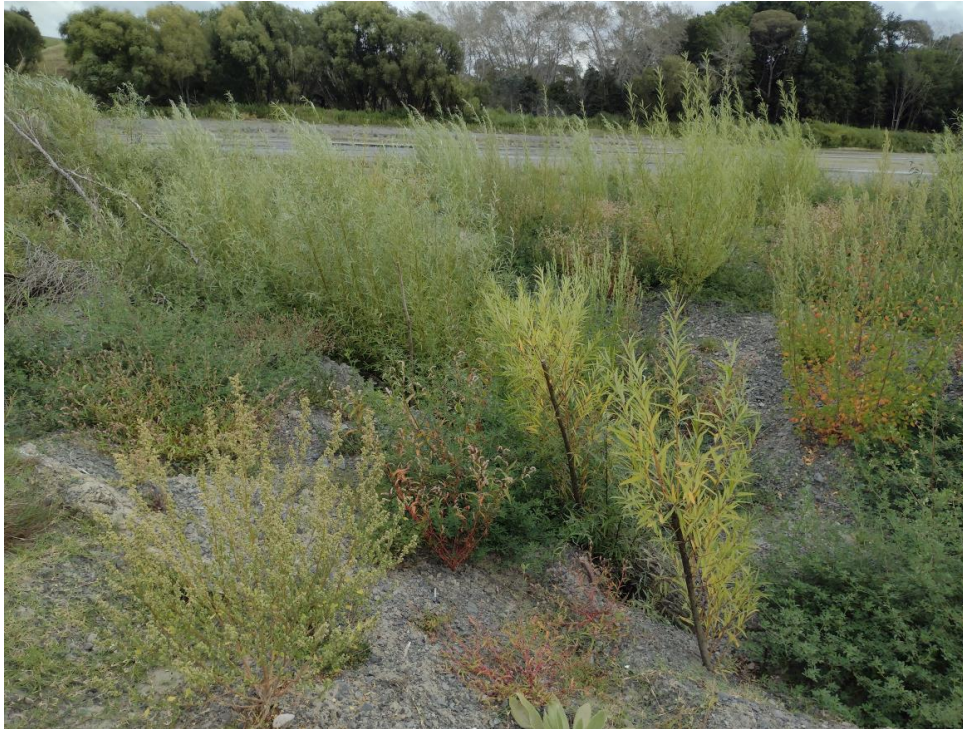
**Figure A19.** Newly planted willow poles.

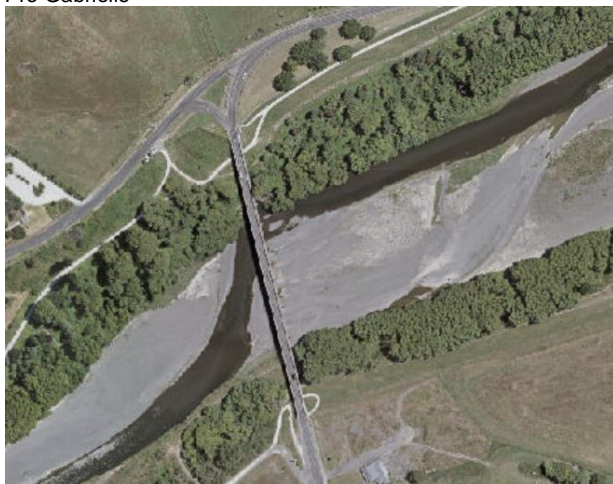
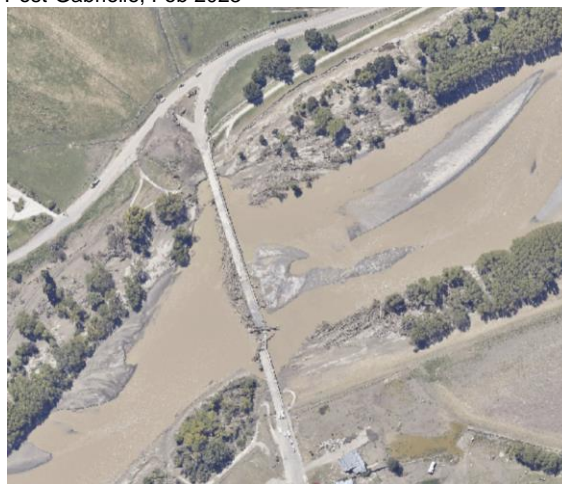
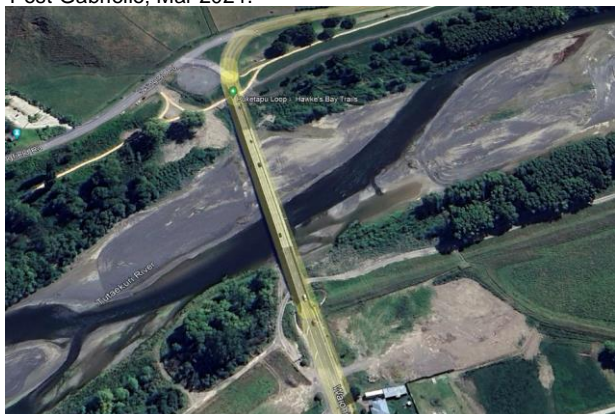
**Figure A20.** Aerial views of the Redclyffe Bridge.

There was substantial bank and berm erosion upstream at both ends of the bridge. Berm erosion also occurred adjacent to the newly upgraded Taradale stopbank. Fortunately these erosion sites didn't grow and cause bridge abutment washout or stopbank breach.

Post-cyclone repairs undertaken included debris removal from the bridge and channel, interim bridge repairs, scour hole filling on the banks and berms, and willow pole planting. Substantial further work will be needed to secure this vulnerable site.

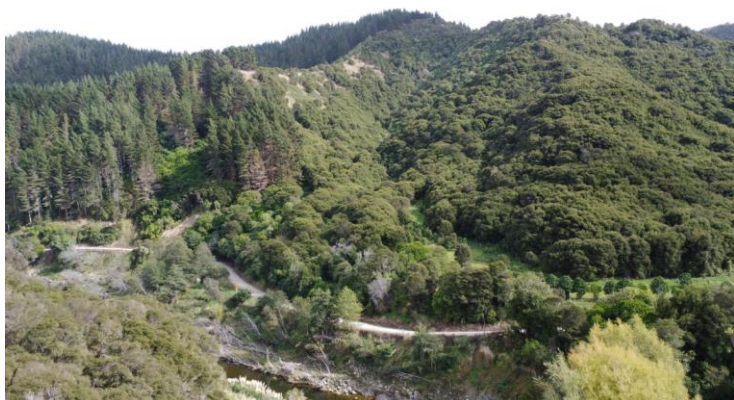
**Figure A26.** Hill slope vegetation contrast – forestry and native regeneration – Waimatā River.

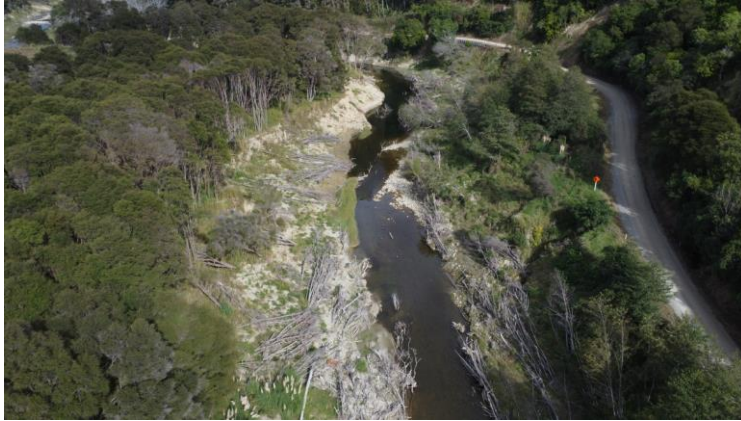
In the case of the Waimatā River there was less evidence of plantation forest debris. The majority of in-channel woody debris appeared to consist of old silver poplar or willow trees, and more recent manuka/kanuka regrowth. The kānuka/mānuka helped prevent erosion on hillsides, but didn't prevent riverbank erosion and hill toe undercutting (Figure A27).

**Figure A27.** Undermined Mānuka/Kānuka trees deposited in riverbed – Waimatā River.

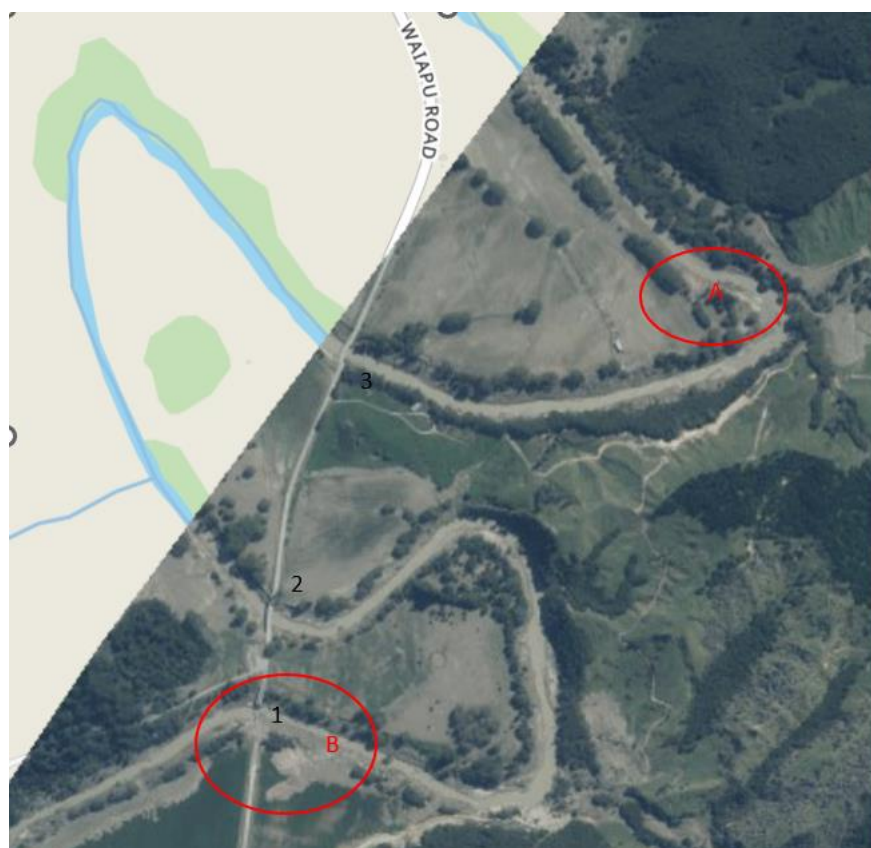
Within Tairāwhiti there were a number of instances where woody debris capture on river berms and floodplain areas reduced downstream movement of flood debris. This was a fortuitous outcome of berm tree location and alignment in relation to in-river and overland flow patterns. In the case of the Hikuwai River there were two sites, upstream of Hikuwai Bridges No. 3 & No. 1, where significant volumes of debris accumulated (see Figures A28 & A29).

**Figure A28.** Hikuwai River – woody debris capture sites.

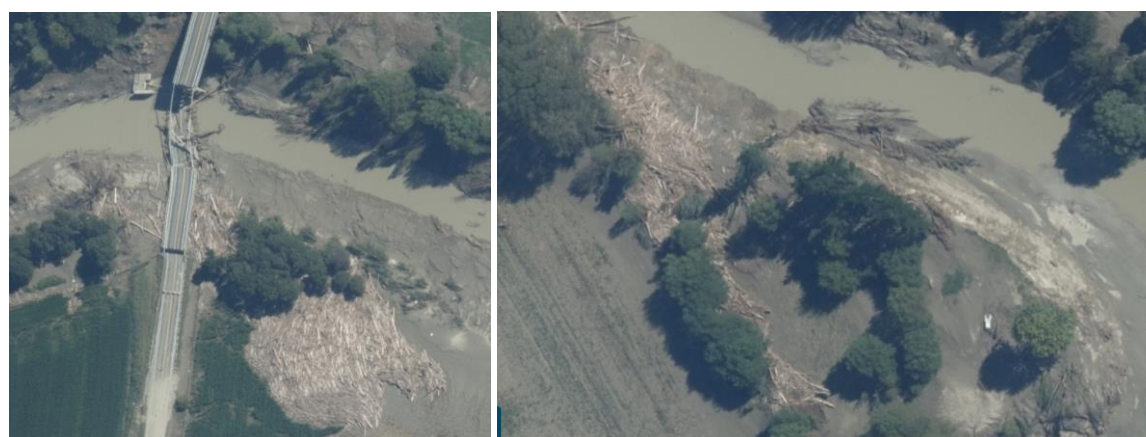
**Figure A29.** Hikuwai River – woody debris capture – Sites A & B.

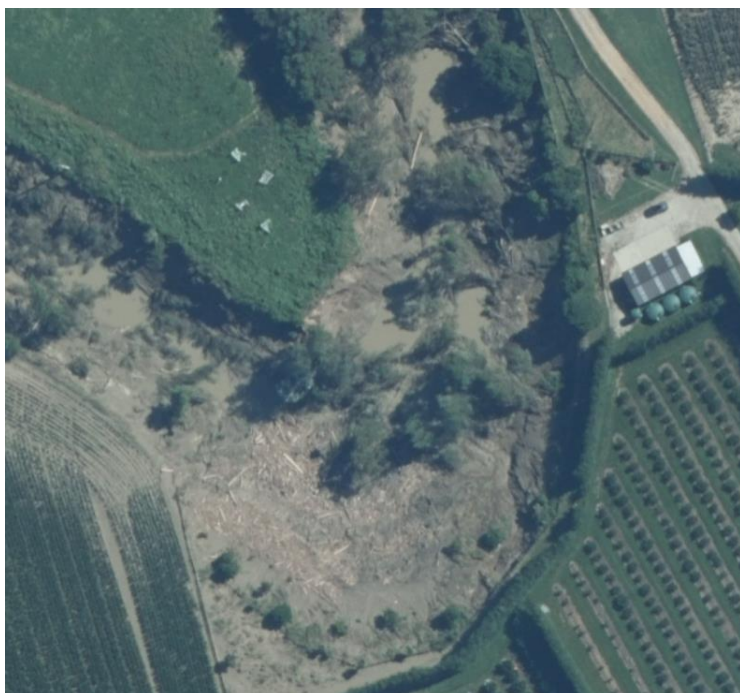
The lower reaches of the Te Ārai channel were badly congested with large trees (mainly willow) before Cyclone Gabrielle. This tree growth roughened the channel, reducing flow velocity and channel flood capacity, and increasing floodplain overflows. The in-channel trees may have reduced bank slumping and erosion and will have reduced downstream movement of up-catchment sourced woody debris (Figure A30). In rivers such as the Te Ārai there may be a compromise to be found between flood capacity, bank stability, and debris capture, by managing in-channel tree type, location, and size.

**Figure A30.** Te Ārai River – woody debris capture in lower reaches.

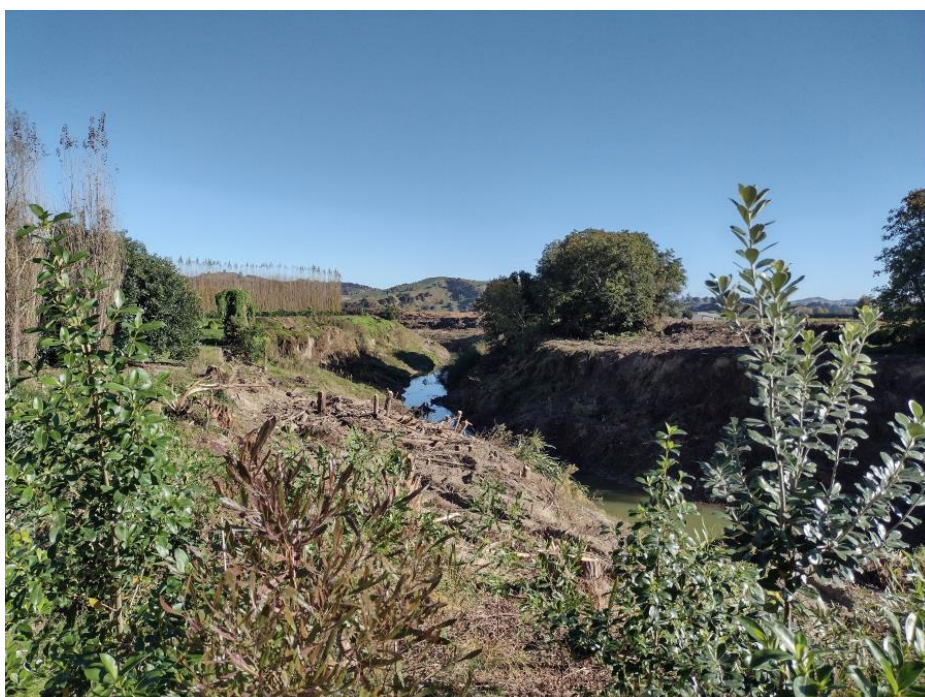
**Figure A31.** Te Ārai River – results of extensive channel debris clearance & tree removal works post Cyclone.

The Hikuwai and Te Ārai River examples suggest that strategic siting of tree rows, at locations such as at berm or floodplain overflow areas, on sharp bends, and upstream of bridges, could help debris capture and reduce downstream debris related damage. This type of approach would need to be implemented along with ongoing localised or extensive channel tree maintenance and debris removal works programmes (Figure A31).

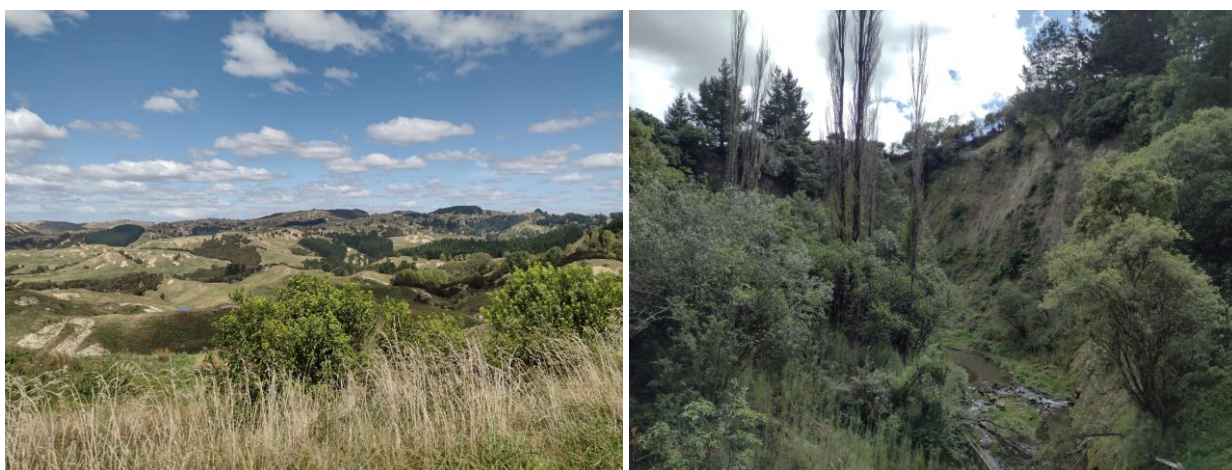
In the case of the Tūtaekurī River catchment, the main woody debris source appeared to be the tributary Mangaone River. This catchment includes plantation forestry but is mainly pastoral hill country with a high erosion potential (Figure A32 left). The waterways are often entrenched within gorges or very steep sided narrow valleys, and heavily vegetated with a range of trees and shrubs (Figure A32 right). This waterway vegetation is vulnerable to wash out and downstream movement during flood events.

**Figure A32.** Pastoral hill country, Mangaone catchment.

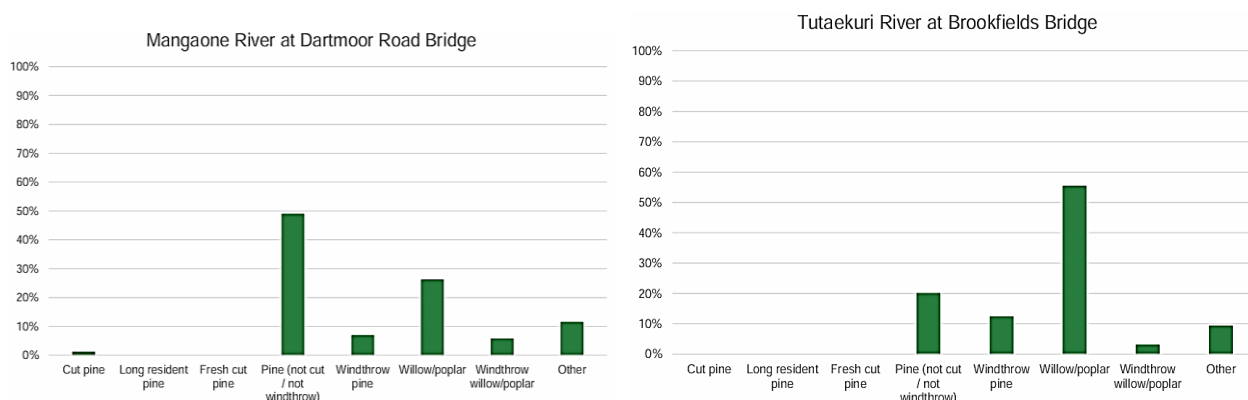
The Cyclone Gabrielle Woody Debris Species Composition Assessment report gives some insight into the categories of tree material making up the woody debris, and the extent to which tree selection and management practices could reduce debris problems in future. For example, Figure A33 shows the woody debris composition at Dartmoor Road Bridge (Mangaone River) and Brookfields Bridge (Tūtaekurī River), respectively. Most of the material at the Dartmoor Road Bridge is pine, whereas at the Brookfields Bridge site it is willow/poplar. This seems reasonable given the Tūtaekurī River reach downstream of Dartmoor is managed for flood protection purposes, and the bank and berm vegetation is mainly willow and poplar.

**Figure A33.** Woody debris composition at a) Dartmoor Bridge and b) Brooklands Bridge.

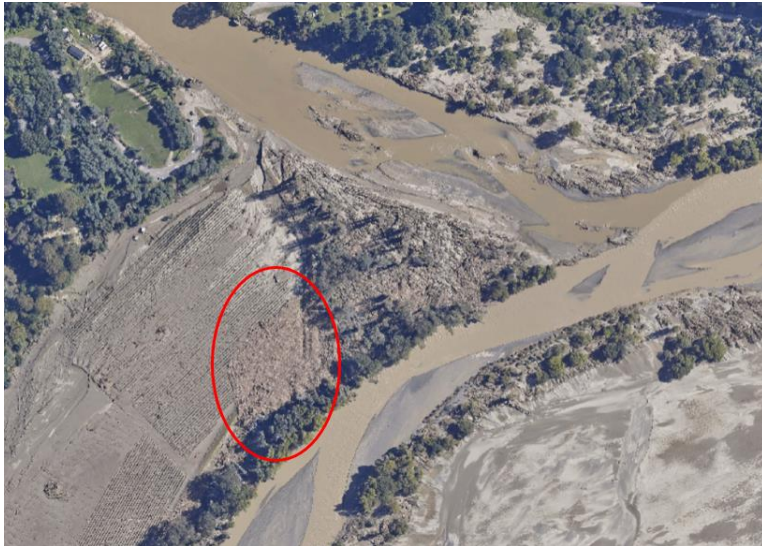
One example was the site on the Tūtaekurī River upstream of the Mangaone confluence. Figure A34 shows a large pocket of woody debris which has moved onto and over the floodplain to be captured landside of berm buffer vegetation. Figure A35 shows woody debris capture on both landside and riverside of buffer vegetation.

**Figure A34.** Floodplain woody debris capture— Tūtaekurī & Mangaone River confluence.

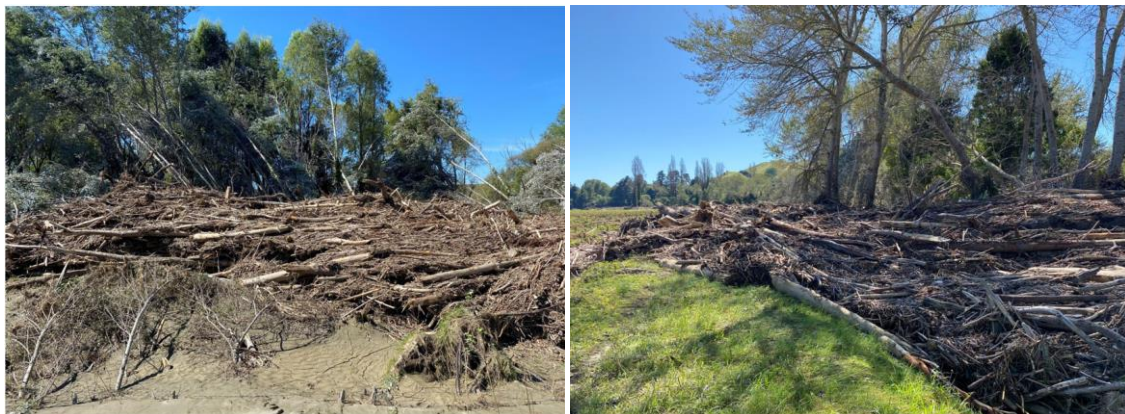
**Figure A35.** Woody debris capture by berm buffer zones – riverside & landside.

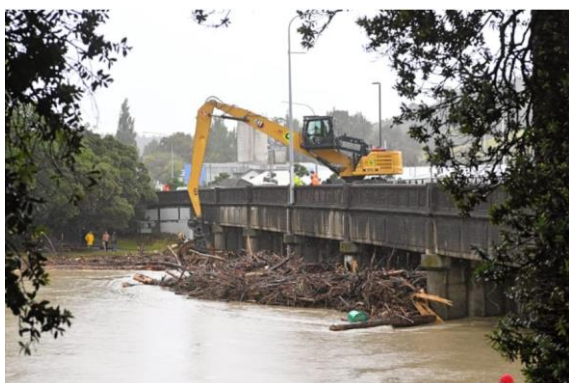
One issue that has become apparent since Cyclone Gabrielle is that bridges, and their waterway capacity, are critical elements of flood protection systems. Bridges, depending on their design and upstream woody debris input, can act as flood bottlenecks and are incredibly effective debris traps (Figures A36 & A37). This of course can stress bridges to the point of collapse – but equally important, reduce river flood capacity with resulting stopbank overflow, breach, and related flood damage. New bridges should be designed with generous waterway/flood capacity provision, allowing for climate change and future flood protection system upgrade. Bridge waterway designs could include a debris supply assessment – and ensure that debris capture is minimised (i.e. appropriate spans, pier spacings and design, and underside levels). Existing bridges could be retrofitted with debris deflectors or lifters (Figure A38), and measures for debris removal during flood should be considered.

**Figure A37.** Woody debris removal during flood.

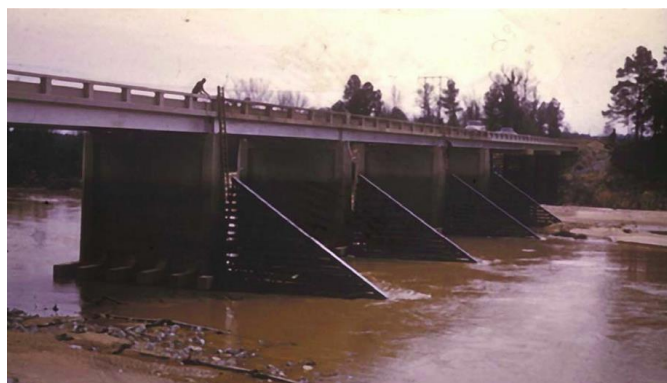
**Figure A38.** Bridge debris fins.
